Document No: DD+DIS152.08E

DRYSTAR 5500 / DRYSTAR 5503

Type 5364 / 100/300

- The troubleshooting guide (TSG) is the complete collection of device symptoms, defects and solutions.
- It is updated regularly.
- Navigation in the PDF document is possible via drop down menus on the front page, the PDF bookmarks or the Adobe Reader full text search engine.
- The TSG additionally contains a section with Tips & Tricks as well as a FAQ (Frequently Asked Questions).

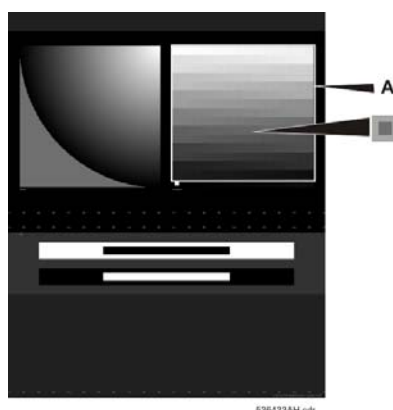
Figure 1: STI-test image

This fault can best be observed in the 256 squares in the STI test image. See Figure 1.

- Defect*
- Film calibration not performed and/or
 - MDM needs re-calibration and/or
 - Printhead profile needs to be calibrated.

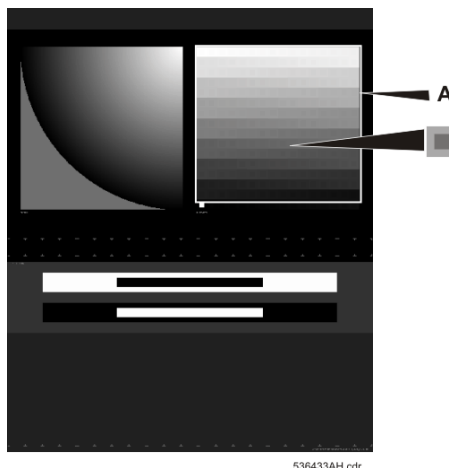
Figure 2

This fault can best be observed in the 'quarter circle continuous grey step' in the STI test image. Refer to Figure 2.

- Defect*
- Sensitometry far away from the real film characteristics - calibration not performed and/or
 - Printhead profile needs to be calibrated.

- Solution*
- (1) Perform a film calibration.
 - (2) Print the STI test image and check the contouring.
 - (3) If the contouring is still not OK, perform an MDM calibration followed by a film calibration.
 - (4) Print the STI test image and check the contouring.
 - (5) If the contouring is still not OK perform a Printhead profile calibration.
 - (6) Perform a film calibration.
 - (7) Print the STI test image and check whether contouring is still visible.

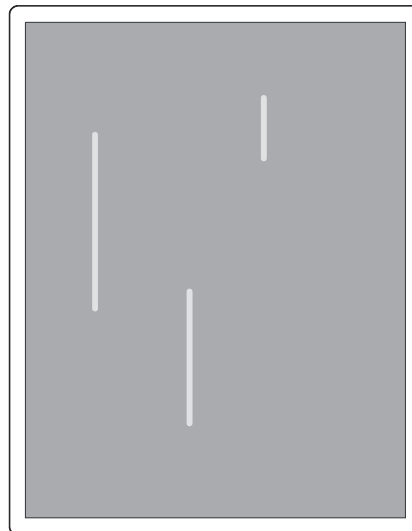
Figure 3

Symptom Dust stripes are most often white, sometimes dark lines, and mostly ragged and not sharp. They are always in transport direction, and are from a few cms long up to the total length of the film.

Defect 1 Dust on the film. The dust particle stays on the Print Head for a certain time. This leads to less heat on the film as long as the dust particle stays between the Print Head and the film.

Defect 2 Cleaning rollers kit not installed or cleaning rollers need to be cleaned

Defect 3 Possibly one or more of the foam seals is damaged.

Defect 4 Dust abrasion coming from front doors of printers with SN < 1189.

- In case not yet installed: Install Cleaning Rollers Kit. Order number CM+3468400. It is installed by default in all DRYSTAR 5500 printers manufactured after September 2004. It is recommended to modify all printers where dust stripes are an issue.
- In case it is installed: Clean it with Agfa cleaning tissues. Advise the customer to clean the cleaning rollers whenever increased dust stripes are visible.

Solution 3 Replace the damaged foam seal by one of the foam seals kit: CM+346170.4*

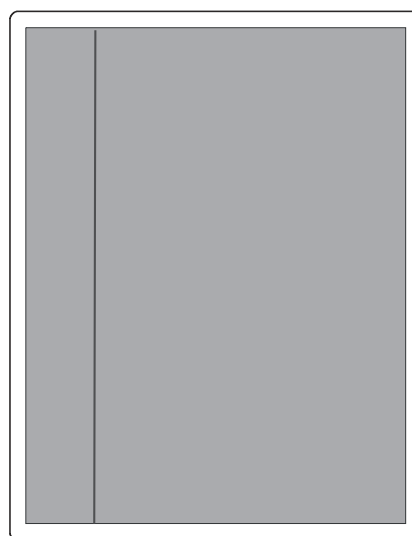
Figure 4

- Symptom*
- Width can be < 1 mm (Sub mm TPH banding) or 0.05 mm (one pixel line).
 - Can be one or more lines.
 - Line can be intermittent.
 - Can be a combination of dark and white lines.

<i>Defect</i>	<ul style="list-style-type: none">• One or more defective resistors of the Print Head (sharp lines)• Shift of the resistor values of the resistor elements (unsharp lines)• Deposits on the Print Head
<i>Solution</i>	<p>(1) Clean the Print Head. See Technical Documentation DRYSTAR 5500/5503, chapter 3.6, 'Check for dust stripes'. This check also contains a 'Resistor check' in case wet Print Head cleaning does not improve the fault and a Print Head profile calibration in case dry cleaning does not improve the fault.</p> <p>(2) If this does not help exchange the Print Head.</p>
<i>Documents</i>	No separate documents are published for this symptom.
<i>Reference</i>	n.a.

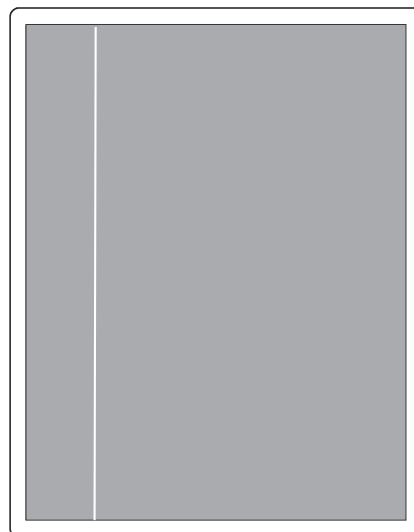
Figure 5

<i>Symptom</i>	<ul style="list-style-type: none">• Width can be < 1 mm (Sub mm TPH banding) or 0.05 mm (one pixel line).• Can be one or more lines.• Line can be intermittent.• Can be a combination of dark and white lines.
----------------	--

<i>Defect</i>	<ul style="list-style-type: none">• One or more defective resistors of the Print Head (sharp lines)• Shift of the resistor values of the resistor elements (unsharp lines)• Scratches<ul style="list-style-type: none">○ Film moves along a sharp mechanical part inside the printer○ Contamination of the Print Head
<i>Solution</i>	<ul style="list-style-type: none">• Clean the Print Head: See Technical Documentation DRYSTAR 5500/5503, chapter 3.6, 'Check for dust stripes'. This check also contains a 'Resistor check' in case wet Print Head cleaning does not improve the fault and a Print Head profile calibration in case dry cleaning does not improve the fault.• If the fault is still visible, check the film for scratches. See section "8.5, Surface artifacts"• In case the fault is still visible exchange the Print Head.
<i>Documents</i>	No separate documents are published for this symptom.

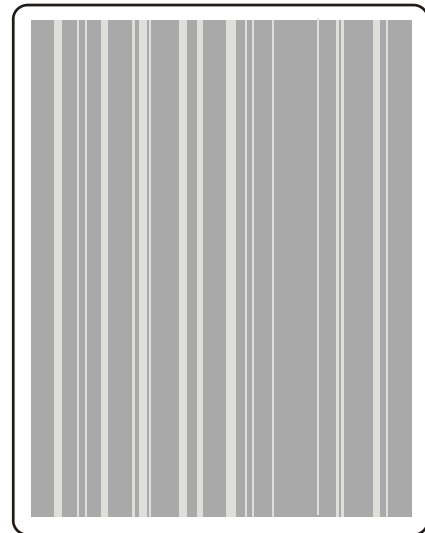
Figure 6

- The stripes can be very small (< 1 mm) to quite wide (> 2 mm).
- The distance from line to line is irregular.
- By keeping the film horizontally with light in the background small scratches can be seen on the emulsion side of the film.

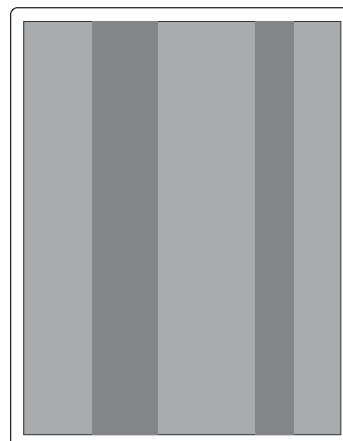
Figure 7

Symptom Lines can be brighter or darker. This fault is named "mm TPH banding" (1 to 5 mm) or "Macro TPH banding" (> 5 mm).

- Defect*
- Dirt on the Print Head
 - Dirt on the print drum
 - Print Head resistor drift
 - Print Head driver defective. See also example images next page.

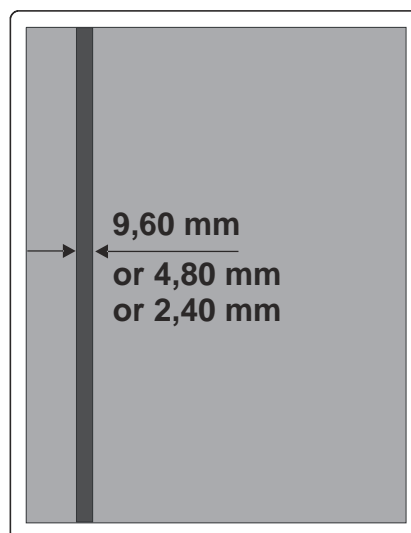
Figure 8

This fault is called "TPH driver banding".

Defect Print Head driver defective

Solution (1) Replace the Print Head.

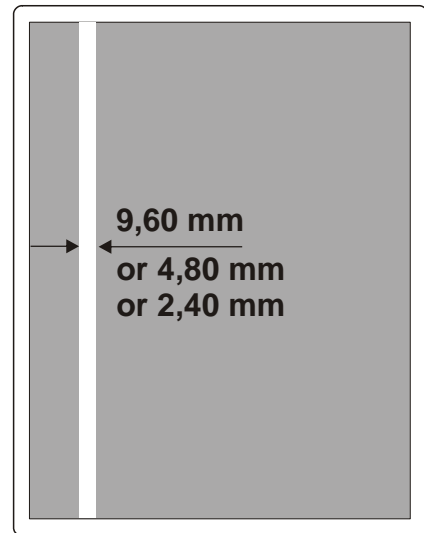
Figure 9

Symptom This fault is called "TPH driver drop".

Defect Print Head driver defective.

Solution (1) Replace the Print Head.

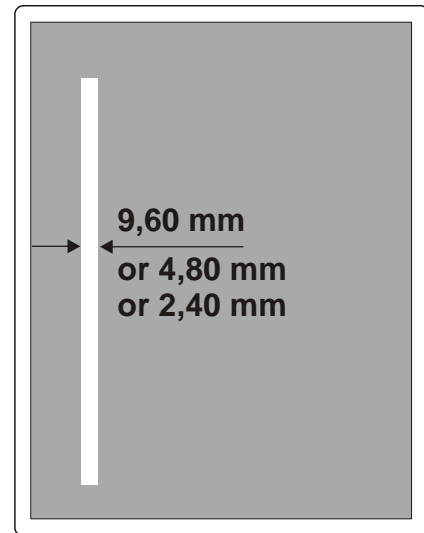
Figure 10

Symptom This fault is called "Intermittent TPH driver drop".

Defect Print Head driver defective.

Solution Replace the Print Head.

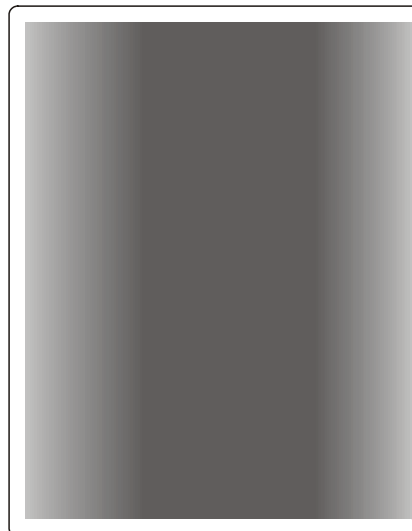
Figure 11

Symptom Uneven density at the right and/or left hand side of the image. Density is too low compared to the middle part of the image.

Defect 1 After exchange of the print drum the Printhead profile was not executed.

Defect 2 Print Head compartment not properly closed.

Defect 3 On or more of the springs, which press the Print Head against the film are not completely hooked in.

Defect 4 Aging of the print drum: Different elasticity of the print drum rubber over the drum width.

Uneven density related to an aged print drum will come up after a certain number of films. With a drum life time of 100.000 prints the uneven density is probably caused by drum aging.

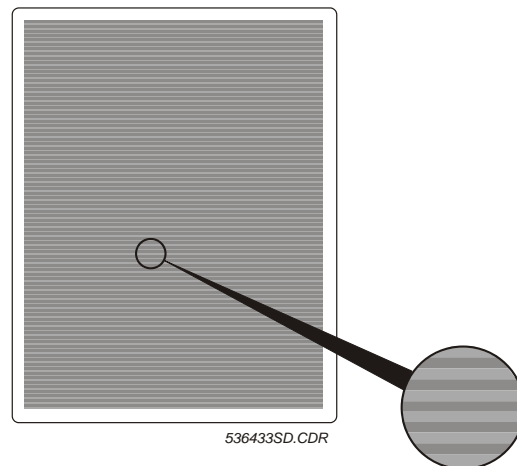
Figure 12

Regular line structure 90° to print direction, also called 'banding' or 'transport shocks'. Usually only visible in low density areas.

<i>Defect 2b</i>	Loose connection between encoder shaft and encoder. → sharp banding lines
<i>Solution 2b</i>	Put some silicone rubber into the hollow encoder shaft or replace encoder shaft and/or encoder.
<i>Symptom 3</i>	22.7 mm image banding in film transport direction Image banding in the film transport direction at a repeating interval of about 22.7 mm.
<i>Defect 3</i>	Toothed belt with one irregularity.
<i>Solution 3</i>	Replace toothed belt.
<i>Symptom 4</i>	48-56 mm image banding in film transport direction Repeating image banding, distance fluctuating between 48 and 56 mm.
<i>Defect 4</i>	Misalignment between tooth of toothed belt and tooth profile of the pulley. A tooth of the belt will not run into the tooth groove on the pulley but remains a while on top of the tooth before sliding into the groove. Probably caused by insufficient rounding at top edges of teeth of pulley. This problem does not appear immediately but after several weeks/months of operation (by creep extension of toothed belt).

Replace drum motor by improved drum motor, spare part number* CM+326021.1.

Replace encoder shaft by the spare part* "CM+339274.2 – Glued encoder shaft assy".

<i>Solution 4</i>	For a short-term solution replace the toothed belt as the problem does not appear with a 'fresh' belt. For a long-term solution replace both belt and pulley.
<i>Symptom 5</i>	110.6 mm image banding in film transport direction Image banding in the film transport direction at a repeating interval of about 110,6 mm.
<i>Defect 5</i>	<ul style="list-style-type: none">• Horizontal mark on print drum or• Unevenness on flat belt pulley or• Defective drum bearings

<i>Solution 5</i>	Check print drum, flat belt pulley and drum bearings.
<i>Symptom 6</i>	129.5 mm image banding in film transport direction Image banding in the film transport direction at a repeating interval of about 129,5 mm.
<i>Defect 6</i>	Flat belt with one irregularity.
<i>Solution 6</i>	Replace Flat belt.
<i>Symptom 7</i>	Banding line 97 mm from trailing edge One banding line approx. 97 mm from the trailing film edge.
<i>Defect 7</i>	Film vibrates when it leaves the cleaning module rollers CM+346840.2 (and smaller index).
<i>Solution 7</i>	Install latest version of cleaning module kit.
<i>Documents</i>	No separate documents are published for this symptom.
<i>Reference</i>	n.a.
<i>Home</i>

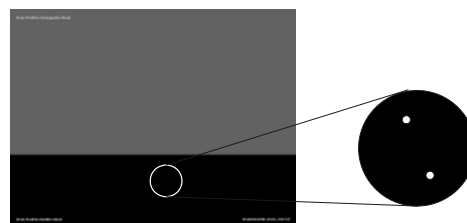
Figure 13

Symptom Pinholes errors show as small transparent and isolated dots, typically < 0.2mm.

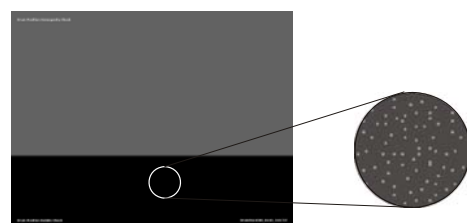
Figure 14

Bubbles must be evaluated with a magnifying glass.

Bubbles disappear by lowering the print drum position.

Defect • Drum position not optimized.

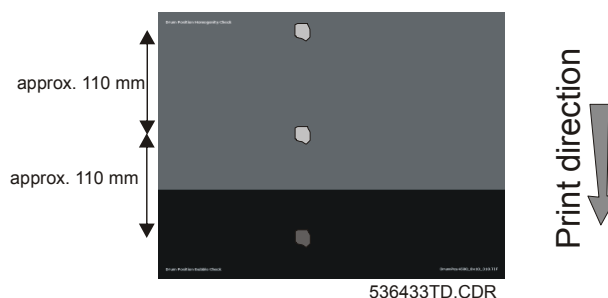
Figure 15

Distance between errors equals the drum perimeter (=110 mm)

Defect	<ul style="list-style-type: none">Dust/dirt on the print drum. Drum errors are easy to detect since the diameter of the drum is small compared to the length of the film. This results in the same drum error a number of times on the same printed film having a distance between errors equal to the drum diameter (=110 mm)
Solution	(1) Print the STI2 test image (2) Clean the print drum with a cleaning tissue soaked in water (3) Print again the STI2 test image.
Documents	No separate documents are published for this symptom.
Reference	n.a.
Home

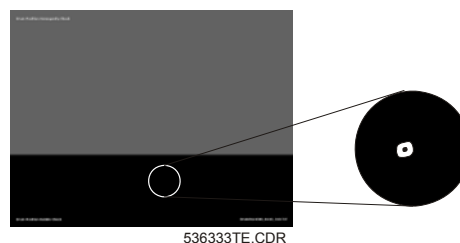
Figure 16

Symptom This fault can best be observed in the STI test image.

Defect	Dust particles or aggregates in the top layer of the film
Solution	Dust particles in the film are a general film problem which cannot be avoided 100%.
Documents	No separate documents are published for this symptom.
Reference	n.a.

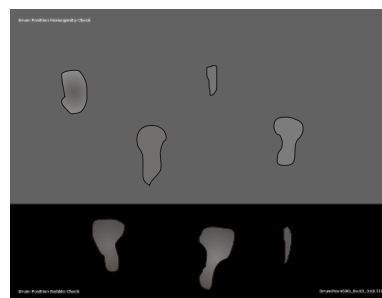
Figure 17

Symptom Blemish is also visible on the light box.

Defect Drum position not optimized.

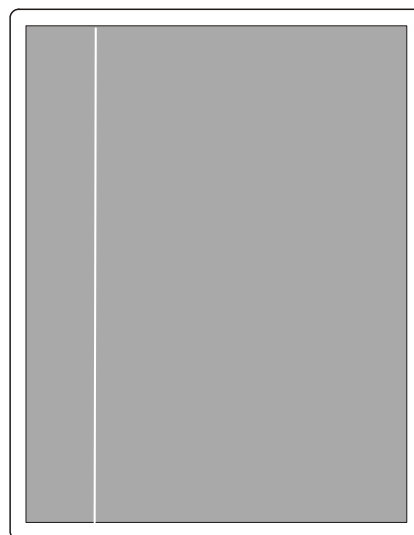
Figure 18

To judge whether a bright line is caused by a scratch, take the film from the light box and check the surface at both sides of the film by keeping it horizontally with light in the background. In addition scratches can be felt with the finger nail.

- (1) Clean the Print Head. See Technical Documentation DRYSTAR 5500/5503, chapter 3.6, section "Check for dust stripes".
- (2) In case this does not improve the stripes, print the image 'footprint_horizontal.tif' (for horizontal stripes) or 'footprint_vertical.tif' (for vertical stripes) from the service menu "8 Adjust & Calibrate - 4 Print Test image - Footprint_xxx.tif". See Figure 34 and Figure 35.
The mechanical part which possibly causes the line artifact will be indicated by the scratch on the film.
- (3) In case the mechanical part which causes the scratch(es) cannot be detected, most likely persistent deposits on the Print Head are the cause of the scratches. In this case replace the Print Head.

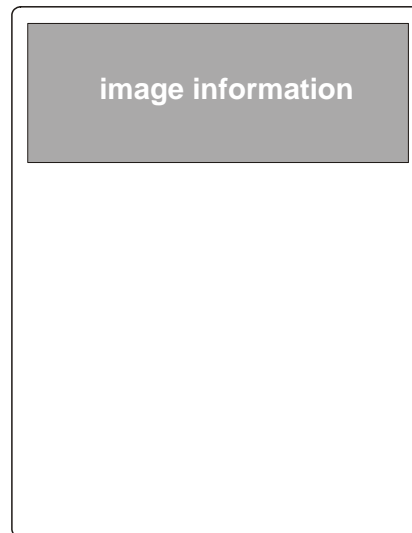
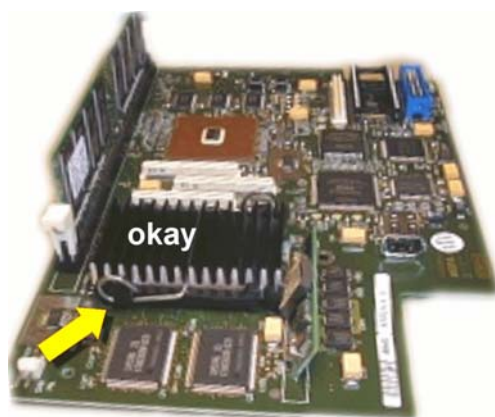
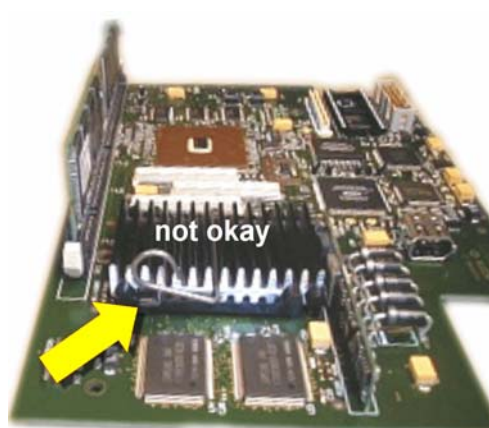
Figure 21

- In addition to the symptoms 'partly printed films' the following error codes are logged in the infocounter and shown on the local display:
 - HC10003 if fault is caused by Crius CPU.
 - HC10053 if fault is caused by Themis CPU.
- The film is re-printed immediately after the partly printed film.
- This fault can be seen in any clinical image - no special test image is required.

- Broken spring holder at the heat sink of the Crius or Themis CPU: Reduced pressure of the heat sink on the CPU leads to higher temperature and so to less CPU performance.
- This fault should only appear at a few printers. Meanwhile the mounting method of the heat sink is changed. The change was not recorded in production. As of approx. SN2190 the improved mounting method was introduced.

- Solution*
- (1) Check the spring holder of the heat sink of the Themis CPU.
 - (2) In case it is defective replace it with spare part* CM+346039 3.

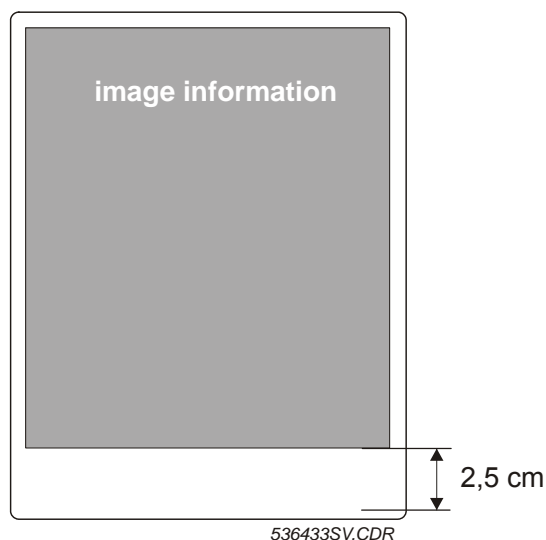
Figure 24

Symptom The image is complete, however printed condensed.

Defect Flat belt mounted with the rough side towards the pulley.

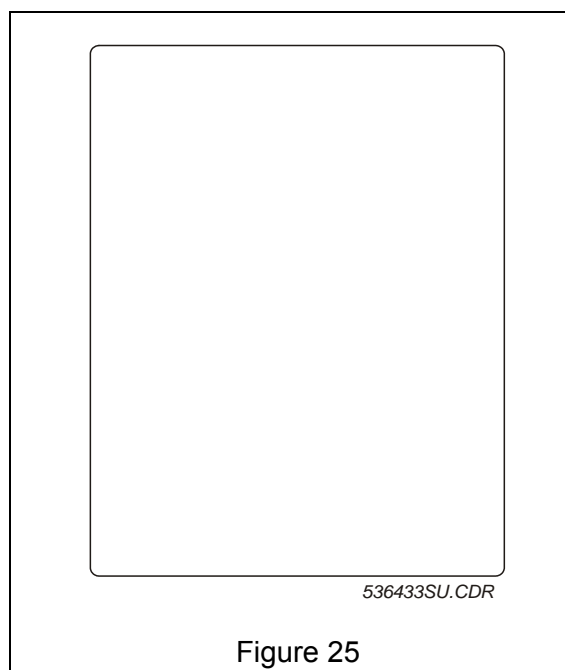
Symptom This fault can can be seen in any clinical image - no special test image is required.

Defect 1 Corrupted film sensitometry file after film calibration failure.

Defect 2 Communication problem between MEC2 board and power supply – only for MEC2 rev. A328189.12

Solution 1 Possibility 1:

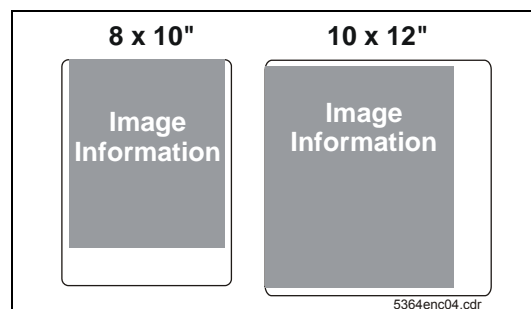
Figure 26: Shifted image information

Symptom 10" films with approx. 3 cm shifted image information.

Defect Due to strong film curl variations of the unprinted films the film may jam between film tray and printhead section or may be transported askew through the printer.

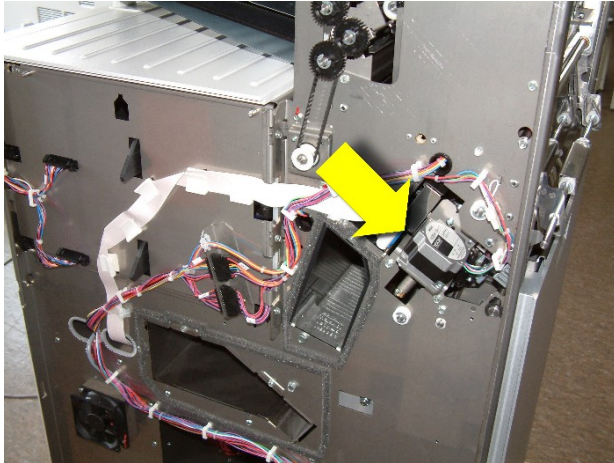
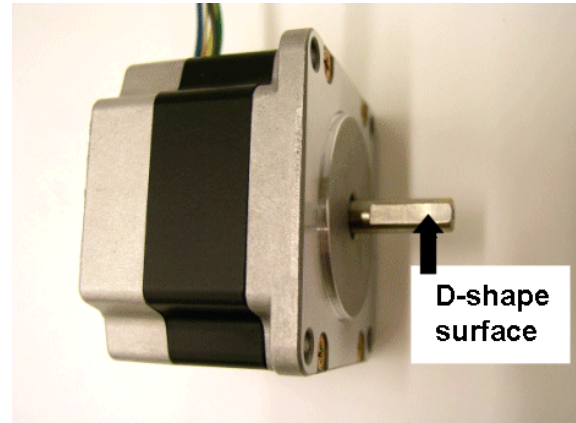
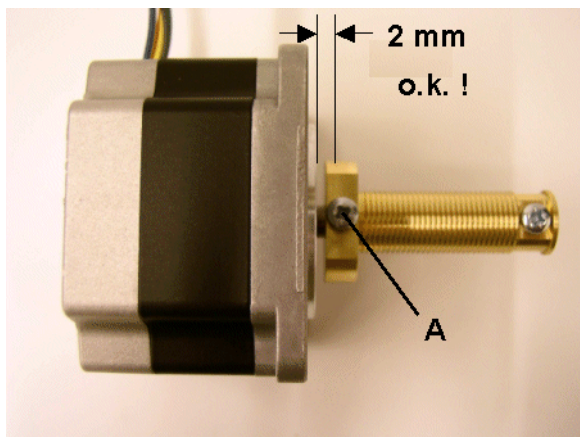
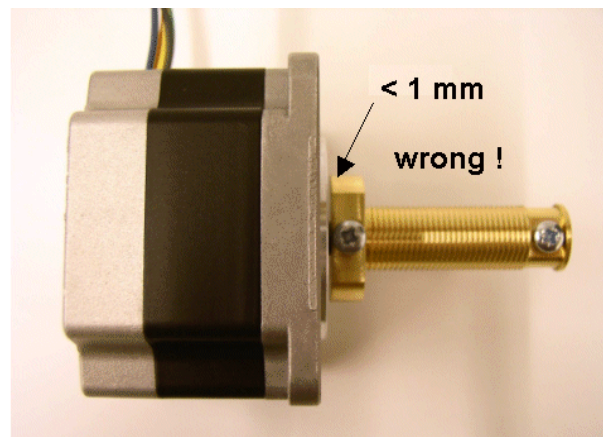
Symptom Distance between densitometer spindle and motor not 2 mm but less than 1 mm. At printers with SN 1262 to 1280 the screw A that keeps the densitometer spindle at the motor, was possibly not mounted on the D-shaped surface, but on the round part of the axle.

Defect Fault in production

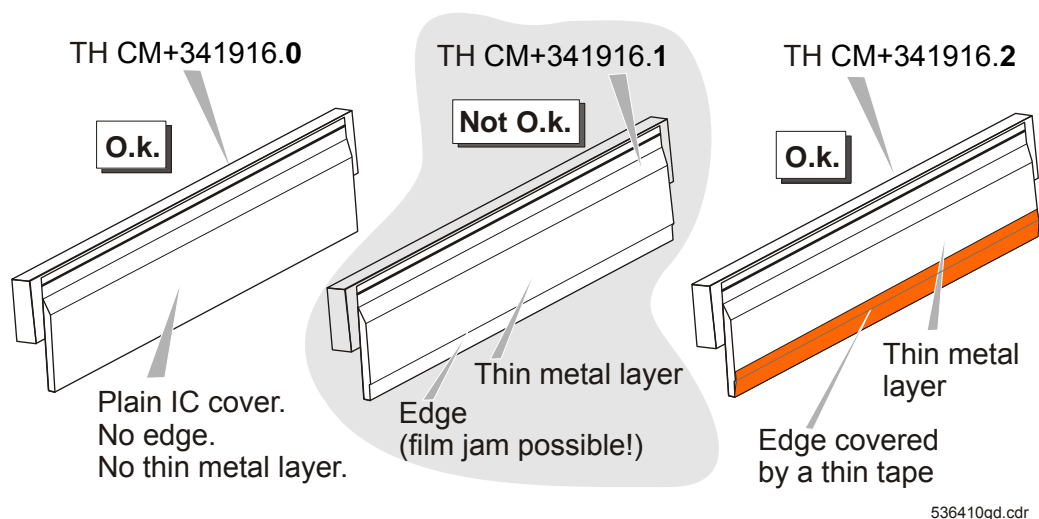
Figure 31

Defect Possible film jam at edge of TH CM+341916.1

Thermal Head CM+341916.1 was delivered as spare part between July and November 2005. It was not used in printers delivered from production. So only printers are affected, where the original TH was replaced by TH CM+341916.1.

THs with spare part number CM+341916.1 have a thin metal layer mounted on the IC cover, which helps to prevent "bubbles" and "vertical print stripes".

Solution Replace Thermal Head CM+341916.1 by TH on stock.

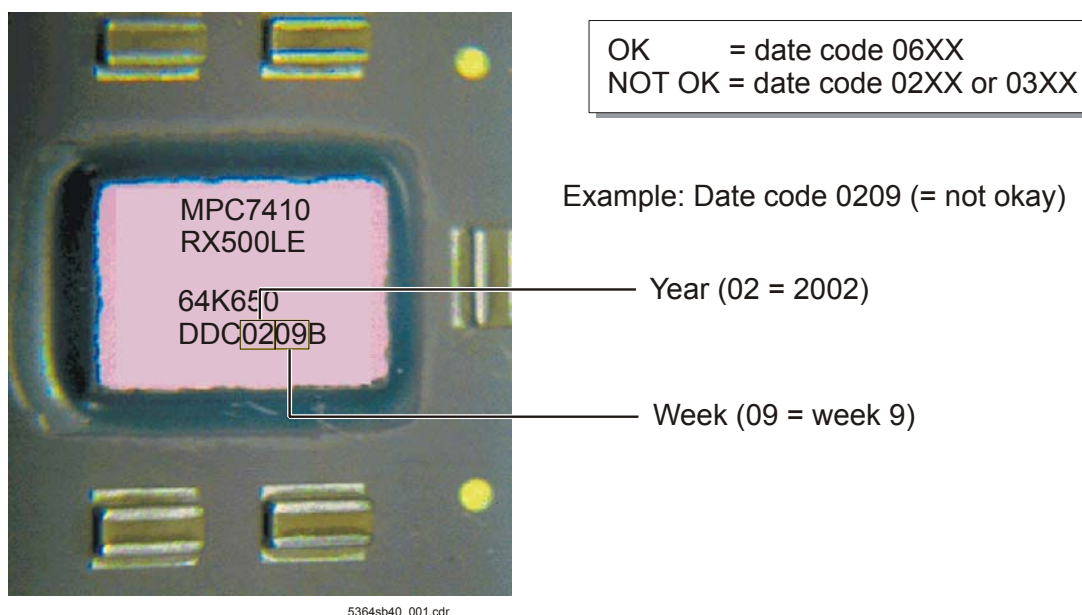
Figure 32: Date code printed on CPU Chip

Symptom DRYSTAR 5503 Printer sporadically does not boot-up:
 It stops booting with display "Error system failure" or "Please wait - Selftest proceeding".
 Another switch off/on usually solves the problem.

Defect Crius and/or Themis CPU with mechanically damaged CPU chip: Depending on the mechanical damage the CPU never fails (little damage) or fails after weeks or months after installation (severe damage). The affected CPU chip can be recognized at its date code printed on the chip: Only printers with date code 02XX and 03XX are affected.

- (1) At the next service intervention remove the heatsink and thermal conductive tape on the Crius and Themis CPU.
- (2) check the date code which is printed on the Crius and/or Themis CPU chip. Refer to Figure 32.
 - If date code = 06XX: No action required.
 - If date code on Themis CPU = 02XX or 03XX: Replace Themis CPU
 - If date code on Crius CPU = 02XX or 03XX: Replace Crius CPU

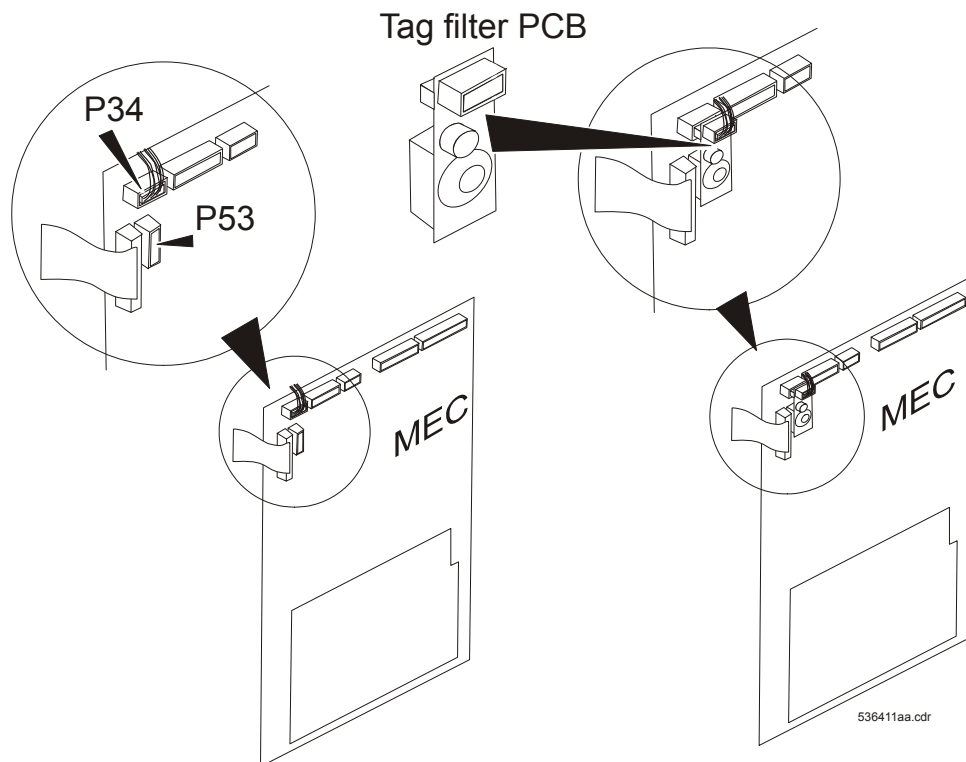
Figure 33: Tag filter PCB as intermediate solution for printers between SN2167 and SN4261

Defect Disturbances in the tag reader signal

Solution 1 Replace tag reader by tag reader CM+339267.3 (or spare part with higher index): This one has a filter included, which avoids disturbances in the signal.

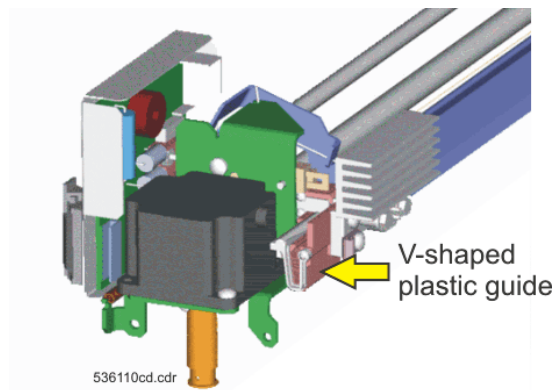
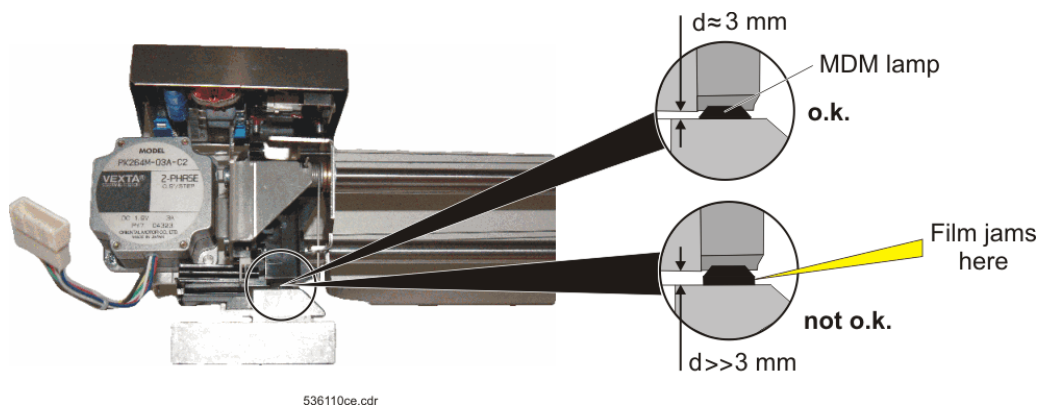
<i>Defect 2</i>	Deformation of the V-shaped film guide in the MDM. See Figure 9. In case of a deformed V-shaped film guide the film sometimes can be jammed during calibration. See Figure 10.
<i>Solution 2</i>	<p>Exchange the MDM. Densitometers on stock with CM+339 1943 or higher index (index = last figure of spare part number) are improved.</p> <p>A temporary solution before the spare part arrives can be to switch off the automatic film calibration (Key Operator menu: 3 Change Settings - 5 Image Quality - 1 General - Select Default for Film Calibration).</p>

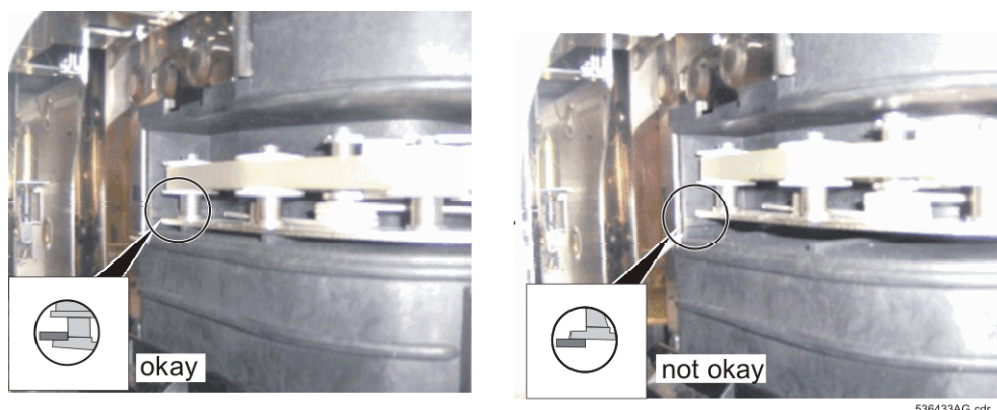
Figure 36

Defect 2 Drive assembly in Horizontal Alignment (HAL) not properly installed. See Figure 36.

Solution 2 Remount drive assembly in HAL correctly.

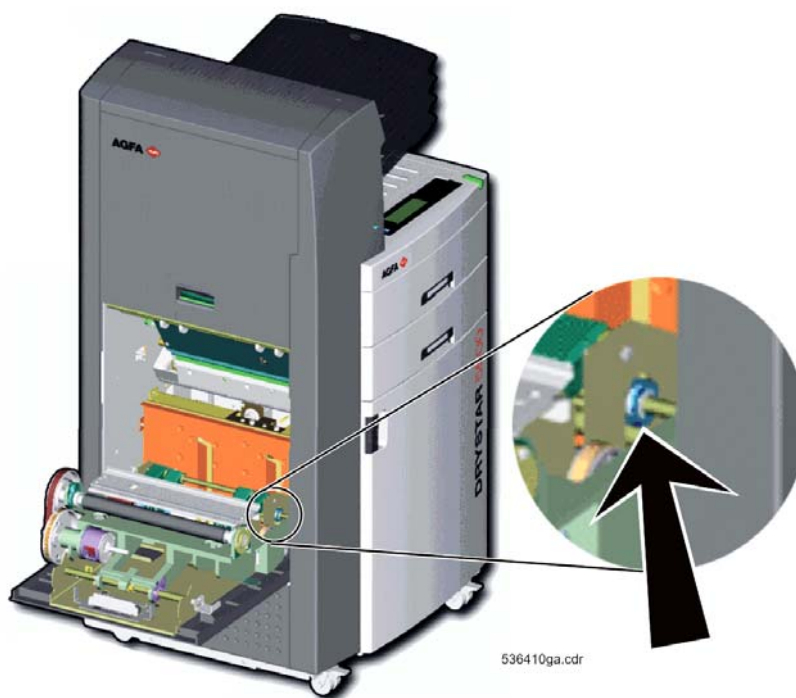
Figure 37: Gear wheel at motor M3

- Symptom*
- Error message "Remove Film jam in Print Section"
 - Error HC11217 in the infocounter
 - Each film jams in the TPH section
- Defect 1*
- Screw that fixes the gear wheel at motor M3 (drum positioning motor) gets loose: The gear wheel can fall down.
 - For other possible reasons see the error descriptions of error HC11217 in Technical Documentation DRYSTAR 5500/5503, chapter 3.3, Appendix, error catalogue.
- Solution 1*
- Tighten the screw at the gear wheel (M3) and secure it with a protection lacquer.

It is recommended to check the screw at gear wheel of M3 at all devices with **SN < 2561** at the next maintenance or service intervention. As of SN2561 the gear wheel is secured with a starlock and the screw is fixed with loctite.

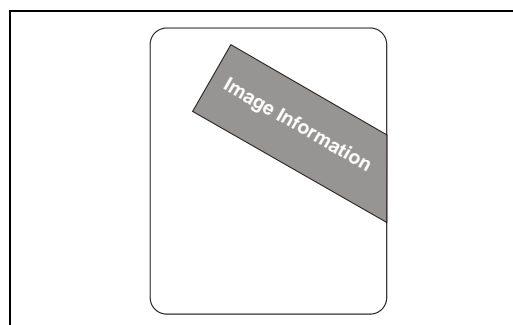
Figure 38

Symptom Sporadically 8 x 10" films are printed skewed. The image information is partly printed. See Figure 38.

Error message 'remove film jam in drum & TPH section' is displayed at the local keypad.

Defect Films of size 8 x 10" are falling down uncontrolled to the bottom plate and are sporadically laying skewed before film is transported to the vertical alignment.

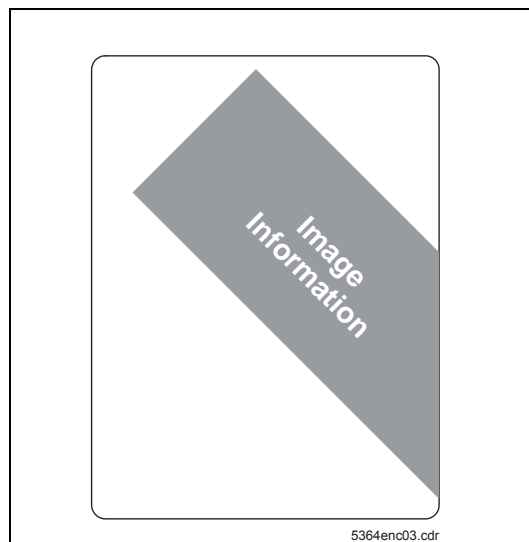
Figure 40: Partly printed images

- Symptom* Frequent film jams in the print head section.
- Message "Remove film jam in Printhead Section"
 - In addition images may be partly printed only - image information is not parallel to the film edge.
See Figure 40

Defect Due to strong film curl variations of the unprinted films the film may jam between film tray and printhead section or may be transported askew through the printer.
