Document No: DD+DIS152.08E

DRYSTAR 5500 / DRYSTAR 5503

Type 5364 / 100/300

- The troubleshooting guide (TSG) is the complete collection of device symptoms, defects and solutions.
- It is updated regularly.
- Navigation in the PDF document is possible via drop down menus on the front page, the PDF bookmarks or the Adobe Reader full text search engine.
- The TSG additionally contains a section with Tips & Tricks as well as a FAQ (Frequently Asked Questions).

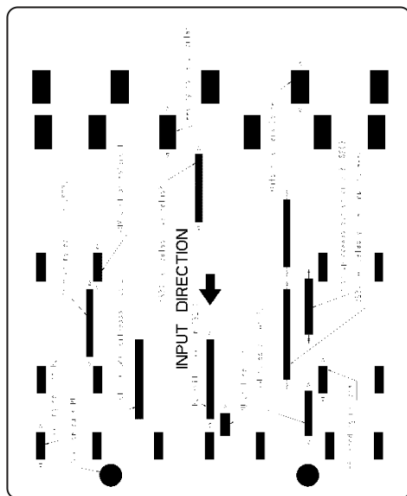
Figure 34: Test image
"footprint_vertical.tif"

- (1) Clean the Print Head. See Technical Documentation DRYSTAR 5500/5503, chapter 3.6, section "Check for dust stripes".
- (2) In case this does not improve the stripes, print the image 'footprint_horizontal.tif' (for horizontal stripes) or 'footprint_vertical.tif' (for vertical stripes) from the service menu "8 Adjust & Calibrate - 4 Print Test image - Footprint_xxx.tif". See Figure 34 and Figure 35.
The mechanical part which possibly causes the line artifact will be indicated by the scratch on the film.
- (3) In case the mechanical part which causes the scratch(es) cannot be detected, most likely persistent deposits on the Print Head are the cause of the scratches. In this case replace the Print Head.

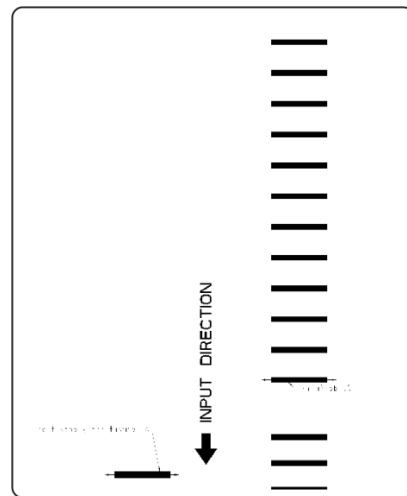
Figure 35: Test image
"footprint_horizontal.tif"

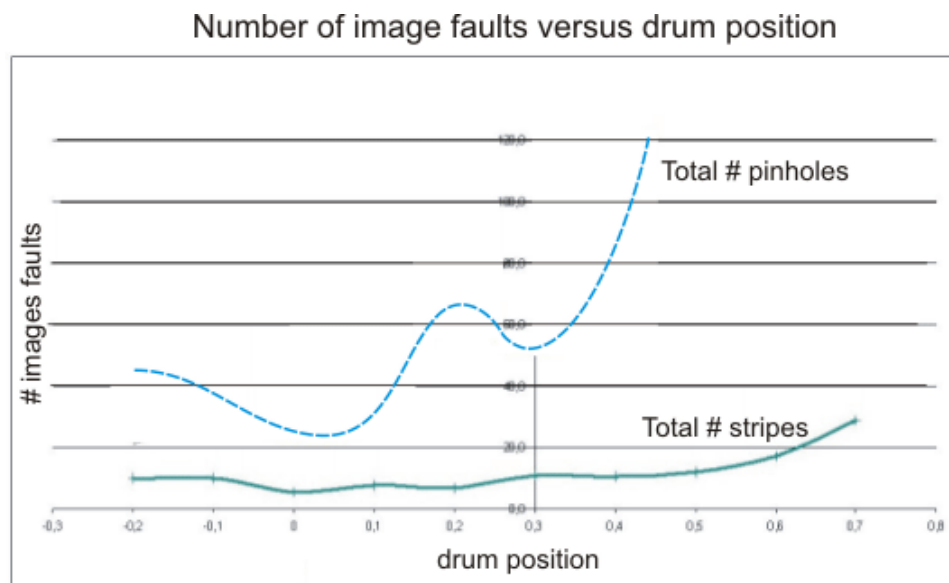
Figure 41

Never try to reduce dust stripes by changing the Print Head position. Deviations of the original drum position might slightly improve dust stripes, on the other hand other image artefacts like pinholes, decreasing Dmax or inhomogeneous printing are the result. See Figure 41.
