### Orthopantomograph® OP200 & OP200 D Orthoceph® OC200 & OC200 D

Troubleshooting Manual

200214 rev 3

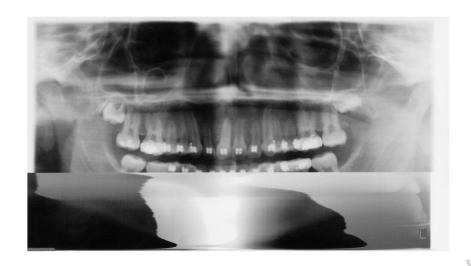
Camera has area with meaningless data	
Why:	Detector is broken	
How is it detected:	Look at reference fig

Possible causes:	Check or test:	Parts related:
Camera has	Look at dropping	Camera/detector
dropped	sensor color

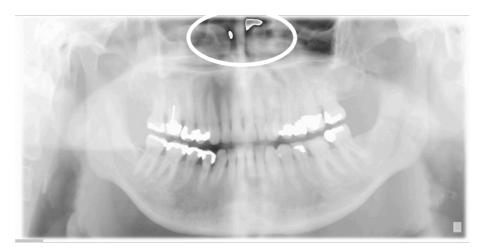
Problem:	Data bits missing
Why:	Bad connection between
	detector and terminal
How is it detected:	Picture has no dynamic

Possible causes:	Check or test:	Parts related:
Detector, Cables, Connectors, Terminal	Check following: 1. Connectors between camera and terminal	Camera/detector, Cables/connectors between detector and terminal,
	<ol> <li>cables between camera and terminal</li> <li>terminal</li> <li>Detector</li> </ol>	Terminal

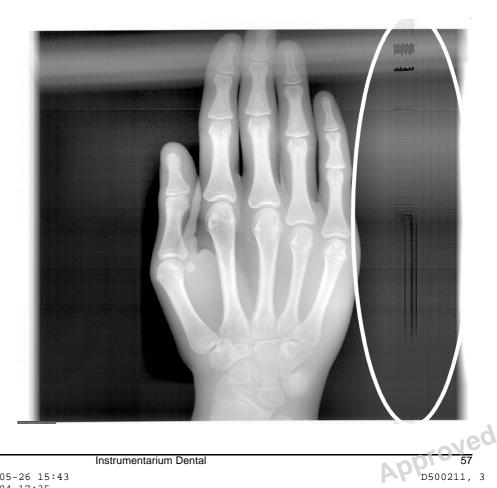
Problem:	Cephaloscan cable failure	
Why:	Cephaloscan cable is broken	
How is it detected:	There is area in picture with no dynamics

Possible causes:	Check or test:	Parts related:
Cephaloscan cable		Cephaloscan cable
	Cephaloscan cable

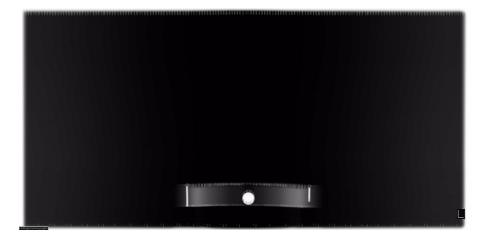
Problem:	Old driver / DICC with dual core processor	
Why:		
How is it detected:	Lines in pictures are shifted

Possible causes:	Check or test:	Parts related:
without new driver/	Onlock that lateot	PC

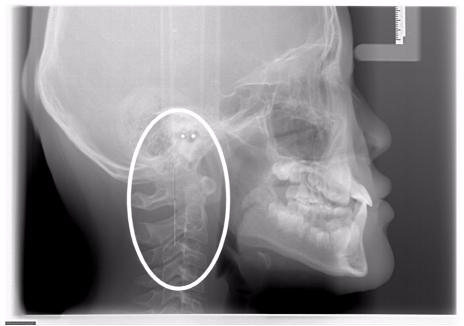
Fig 2.1. Problem areas in pictures.

Problem:	There is not enough resources in PC
Why:	Ongoing unnecessary process and programs
How is it detected:	Random needles in picture

Possible causes:	Check or test:	Parts related:
	Check that there is	
	not used	
	unnecessary	
	process and	
	programs
