Service Manual

1.1 This Service Manual should be referred to for details of the J1, J2, J3 and the J5 general purpose, three or four-section, mobile, operation tables, REF 80-820-14, 80-800-11, 80-810-26, 80-810-41, 80-830-10 (serial numbers J1AA8E0000, J2AA8E0000, J3AB8E0000, J3RB8E0000, J4AB8E0000 respectively, or above).

1.2 Operation tables J1, J2 and J5 are similar. The J3 operation table is specially designed to meet the needs of gynaecological procedures, in addition to its suitability as a general purpose table. The differences between the J1, J2 and J5 tables, and the J3 table, are detailed in Part 7 of the Instructions for Use.

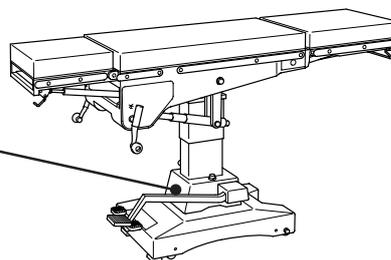
The Serial Number Plate is located on the pedestal as indicated.

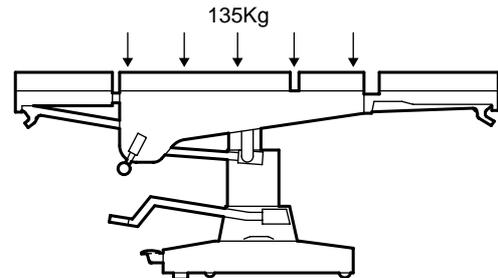
Retention of Adjusted Height: The table will retain its adjusted height with a load of 135kg uniformly applied to the trunk sections.

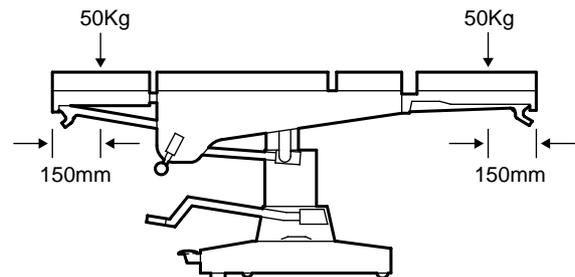
Longitudinal Deflection Load: The table will withstand a load of 50kg applied at a point 150mm in from either end of the head or leg section.

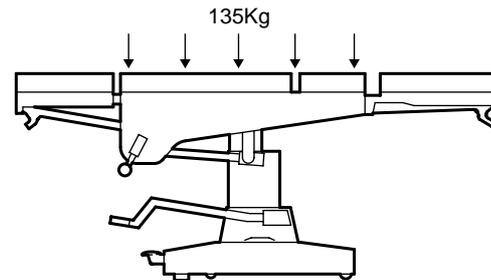
Retention of Adjusted Height: The table will retain its adjusted height with a load of 135kg uniformly applied to the trunk sections.

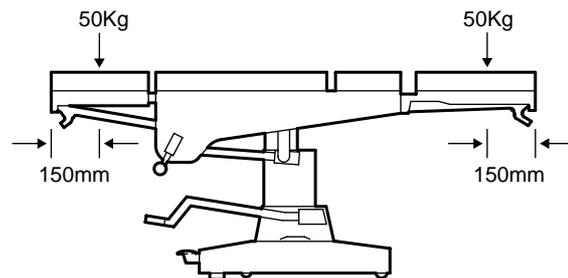
Longitudinal Deflection Load: The table will withstand a load of 50kg applied at a point 150mm in from either end of the head or leg section.

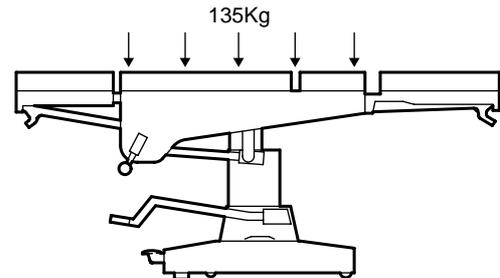
Retention of Adjusted Height: The table will retain its adjusted height with a load of 135kg uniformly applied to the trunk sections.

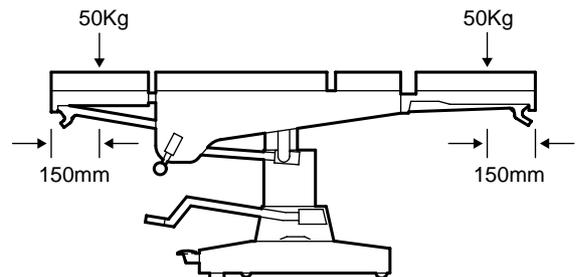
Longitudinal Deflection Load: The table will withstand a load of 50kg applied at a point 150mm in from either end of the head or leg section.

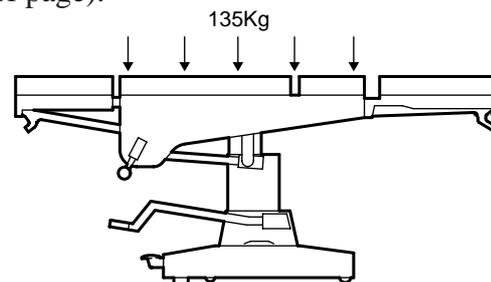
Retention of Adjusted Height: The table will retain its adjusted height with a load of 135kg uniformly applied to the trunk sections. (Note. Graphic is indicative only, for J5 sections see main graphic at foot of page).

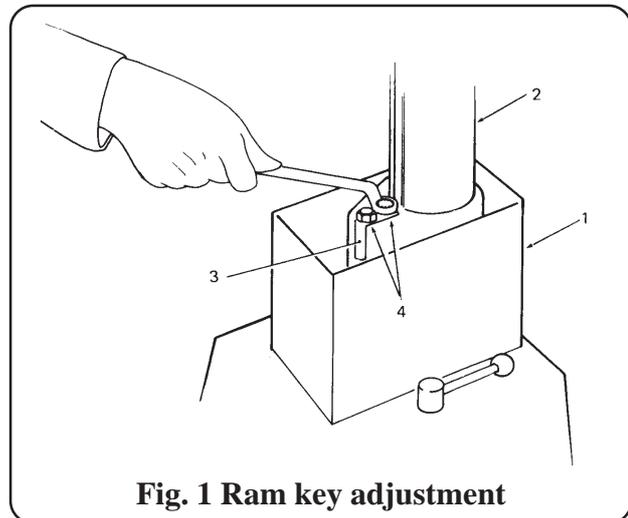
Hydraulic Cylinder (Fig. 1)

4.8 Raise the table top to its maximum height again and release the ram cover securing screws at the top. Lower the 3-section telescopic cover (1) to expose the ram (2) and ram key (3).

4.9 Remove the ram key, clean out keyway and refit key.

4.10 Examine ram surface for rust and, if present, clean off with fine emery cloth. Lubricate exposed surface of ram. Seal the top of the cylinder with cloth wound round the ram to prevent damage if using emery cloth.

4.11 Before refitting ram cover, check that table will raise and lower smoothly. If this is not the case, the ram key is probably secured too tightly. Release the key attachment bolts (4) slightly to remove excessive friction, then retighten.

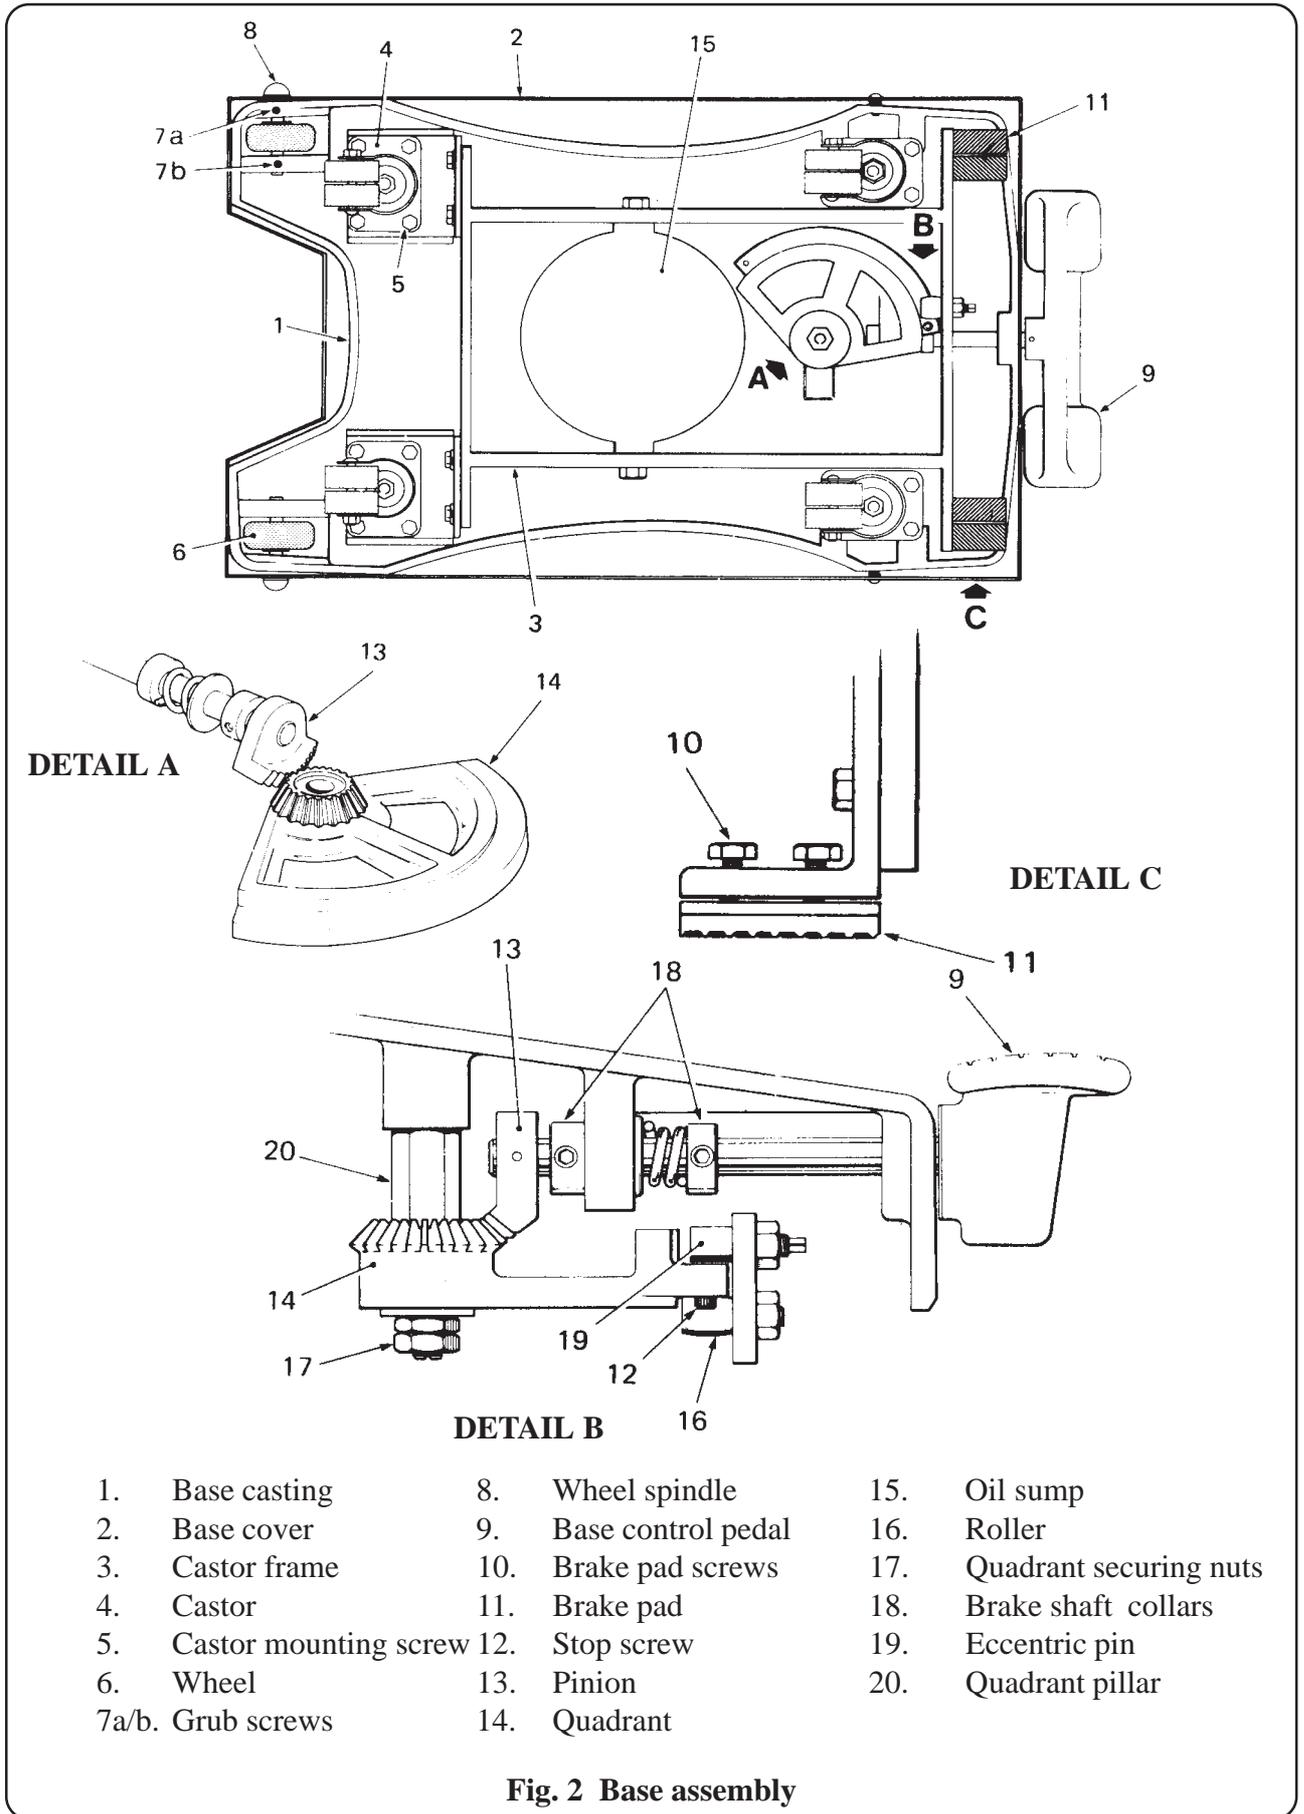
| 1. Base casting | 8. Wheel spindle | 15. Oil sump |

- i Withdraw grub screw (7a) just sufficiently to be able to tap out the domed wheel spindle (8) from the inside, while still retaining the bush in position.
- ii Slacken grub screw (7b) then fit replacement antistatic wheel with original domed spindle. Adjust position of bush under grub screw (7b) to accommodate width of new wheel, then retighten grub screw (7a) into the dimple of the spindle.
- iii Finally, tap the inside bush under grub screw (7b) to make a close fit against the wheel and then tighten grub screw (7b).

- i Note the direction of tread pattern of the worn pad (11), before removing pad.
- ii Remove the two hex screws (10) securing brake pad to frame and install new pad, with the tread pattern facing in the same direction as that noted in (i) above.

- i Remove socket head stop screw (12) from beneath cut-out end of quadrant (14).
- ii Turn the quadrant clear of the roller (16) remove hex. nuts (17) and withdraw the quadrant. If quadrant teeth are broken, fit new quadrant. For renewal of quadrant pinion, carry out the procedure detailed in the following paragraph.

- ix The eccentric pin (19) should be adjusted to take up any excessive play between quadrant and roller.

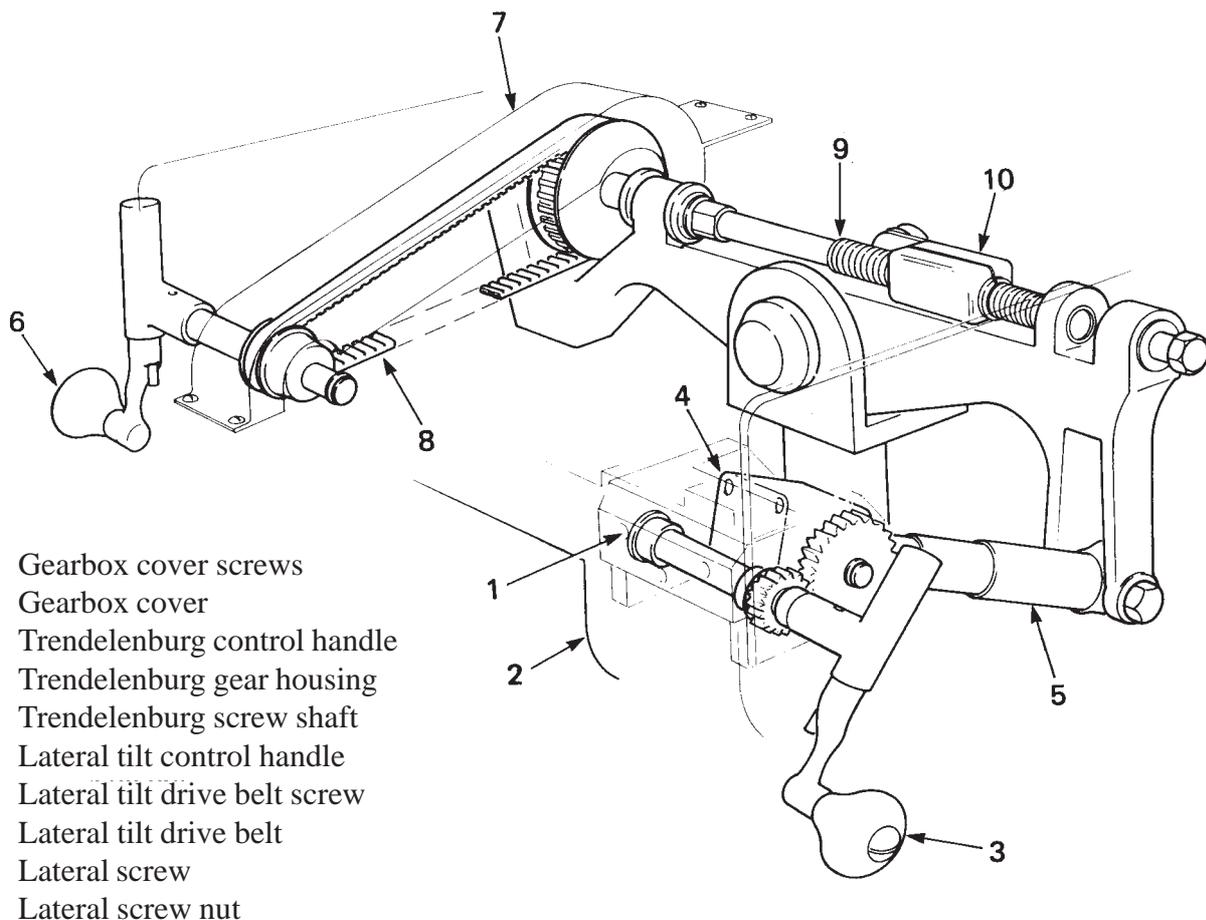
**Fig. 3 Gearbox of J2 and J3 operation tables
(J1 and J5 table similar, without lateral tilt)**

4.15 Check operation of the lateral tilt control handle (6) and ensure that full table top movement is achieved in both directions (see Technical Data). The lateral screw is driven by a toothed rubber drive belt (8). The condition and tightness of the drive belt should be examined periodically. If the drive belt is damaged or has become stretched (lack of positive movement when operating control handle) the belt will need to be replaced (refer to section 4.30). An examination to check

Replacing lateral tilt drive belt (Fig. 3 and 12) - J2 and J3 tables only

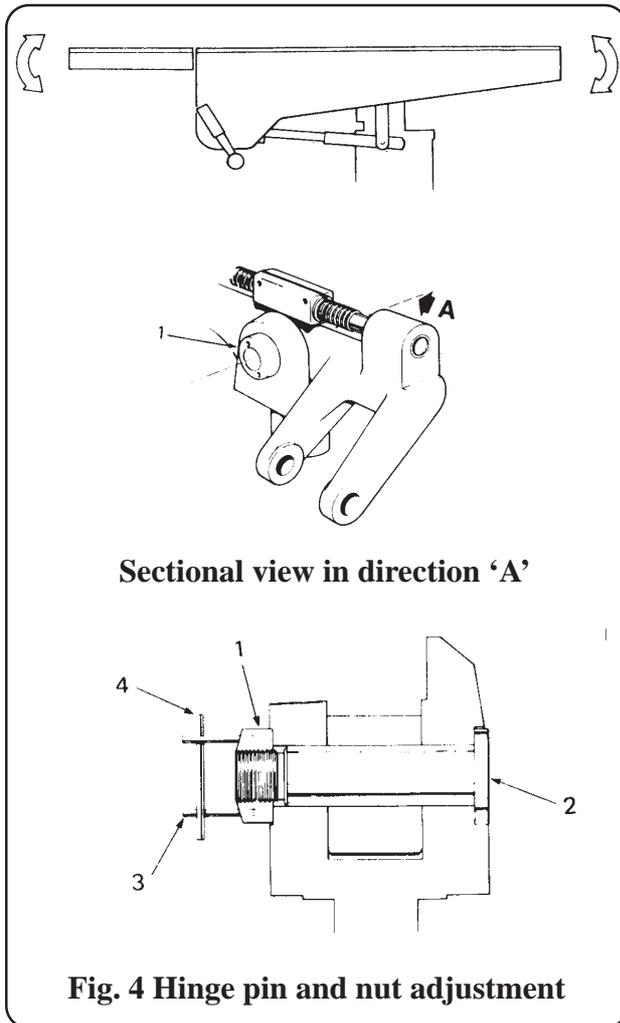
4.16 Pull table top as shown in Fig. 4 to check for excessive play in the direction of the arrows. If there is excessive play present, check to see if hinge nut (1) and bolt (2) are loose. If so, * tighten hinge nut (1) against hinge bolt (2) sufficiently to take up the slackness. To do this, Eschmann recommend using two short lengths of 3/16 in. diameter round bar (3) inserted in the nut sockets, as illustrated in Fig. 4 and applying an improvised tommy bar (4) to turn the nut.

***Note:** This could also indicate play in Trendelenburg gear. If this is the case the complete Trendelenburg screw assembly must be replaced. For removal procedure, see section 4.18.

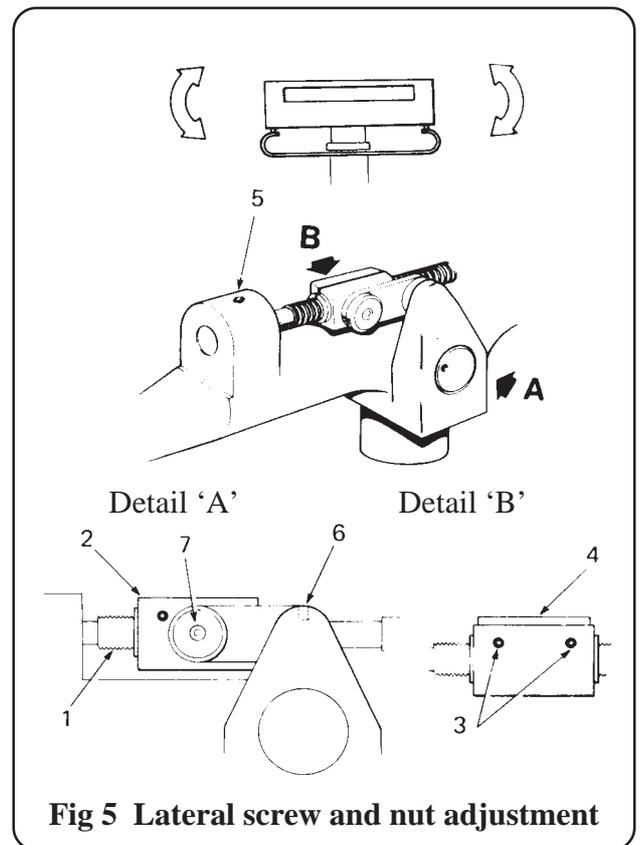
Lateral screw and nut (Fig. 5)

4.17 Place table top in reverse Trendelenburg position, then select Lateral Tilt and operate control handle to test movement is satisfactory. Pull as shown in Fig. 5. If undue play is suspected proceed as follows:

- i Check secureness of link pivot set screws (6) and (7).
- ii Check secureness of grub screw on yoke (5) which locks lateral screw bearing.

iii Finger testing at the point where the lateral screw (1) passes through the nut (2) will establish the need for the nut adjustment. First try tightening socket head screws (3) on nut. If excessive play is still present, shim removal will be necessary. Proceed as follows:

- (a) Unfasten socket head screws (3) on nut and extract shim pack (4).
- (b) Remove shims (0.002 in thickness per shim, approx.) one at a time until play is *just* taken up on re-tightening.

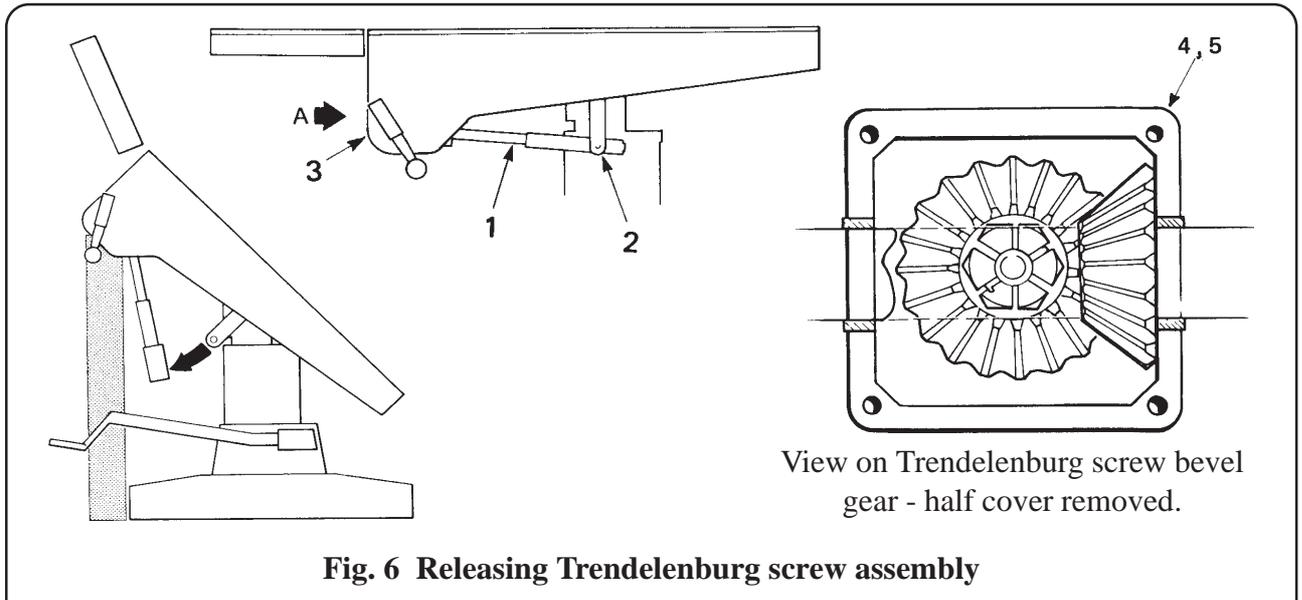
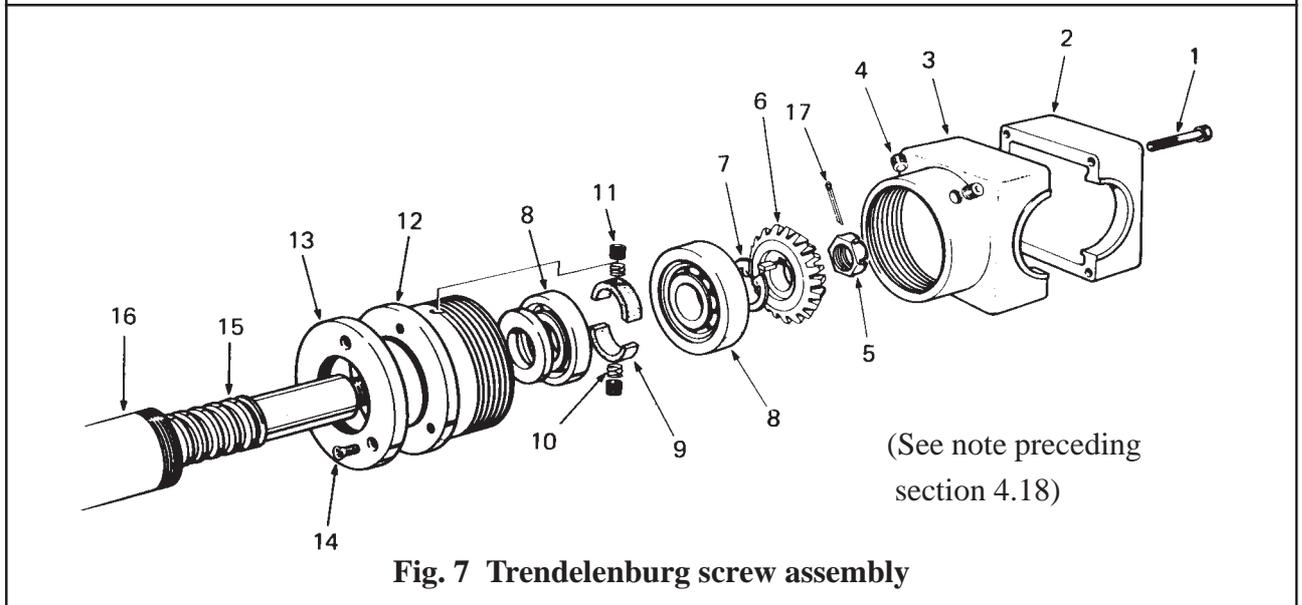
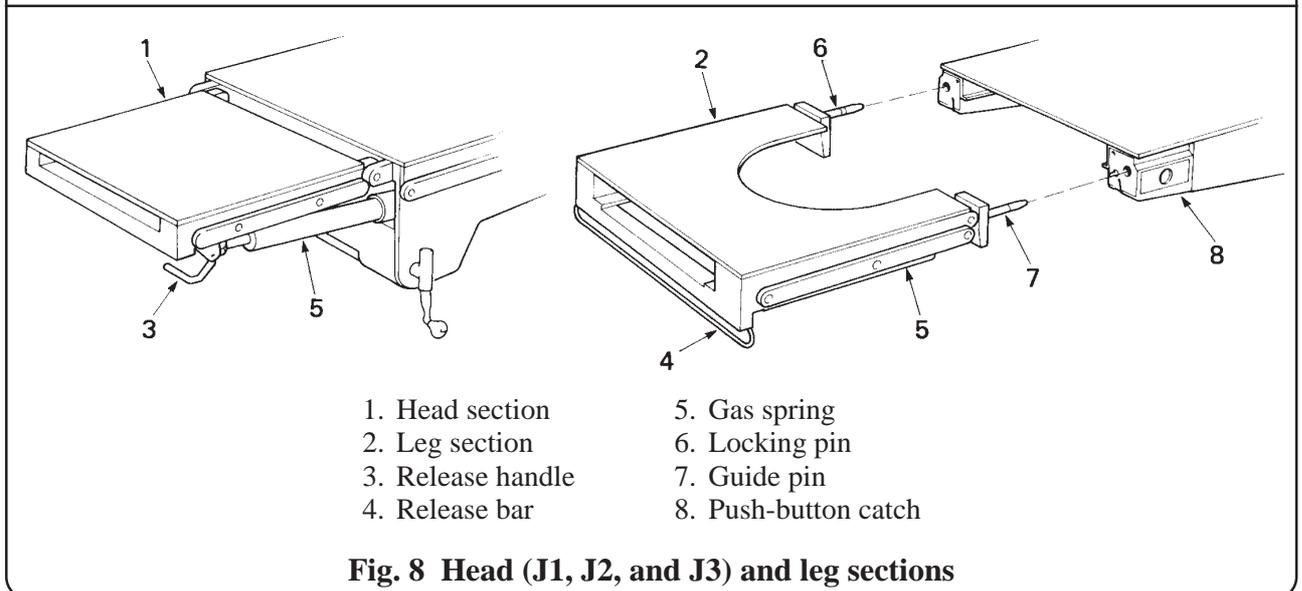
- i Remove the leg flap.
- ii Unscrew and remove the end cap tubes from the Trendelenburg screw assembly.
- iii Using torque screwdriver (Part No. 759581 set to 20-25 lb.in. and fitted with adaptor T2095 and 20mm socket), check the setting by locating socket over the hexagon on the end of the leadscrew and turning the torque screwdriver.
- iv If the leadscrew rotates before the torque screwdriver reaches 20-25 lb.in. the friction collar requires adjusting as (v) below. If the leadscrew does not rotate the friction collar setting is correct and requires no further adjustment and the table can be reassembled.
- v Adjust the friction collar by slackening the

single grub screw that locks the torque adjuster nut and removing the three screws securing the cap ring located at the rear of the gearbox housing thus exposing the torque adjusting nut. Locate spanner (tool number T2097) onto the torque adjuster nut and tighten or slacken to gain the correct setting (i.e. the torque setting is above that given in (iii) above but operation of the Trendelenburg handle is not too difficult).

- vi Replace the cap ring and secure using the three screws, lock the torque adjuster nut by tightening the single grub screw and reassemble the table.

Replacement of Trendelenburg screw (Fig. 6 and 7)

4.29 To replace the Trendelenburg screw, remove the old Trendelenburg screw assembly from the operation table as detailed in 4.18. Fit a new Trendelenburg screw assembly (latest style see note in 4.18) and adjust it to the correct torque setting as detailed in section 4.20. Reassemble the table.

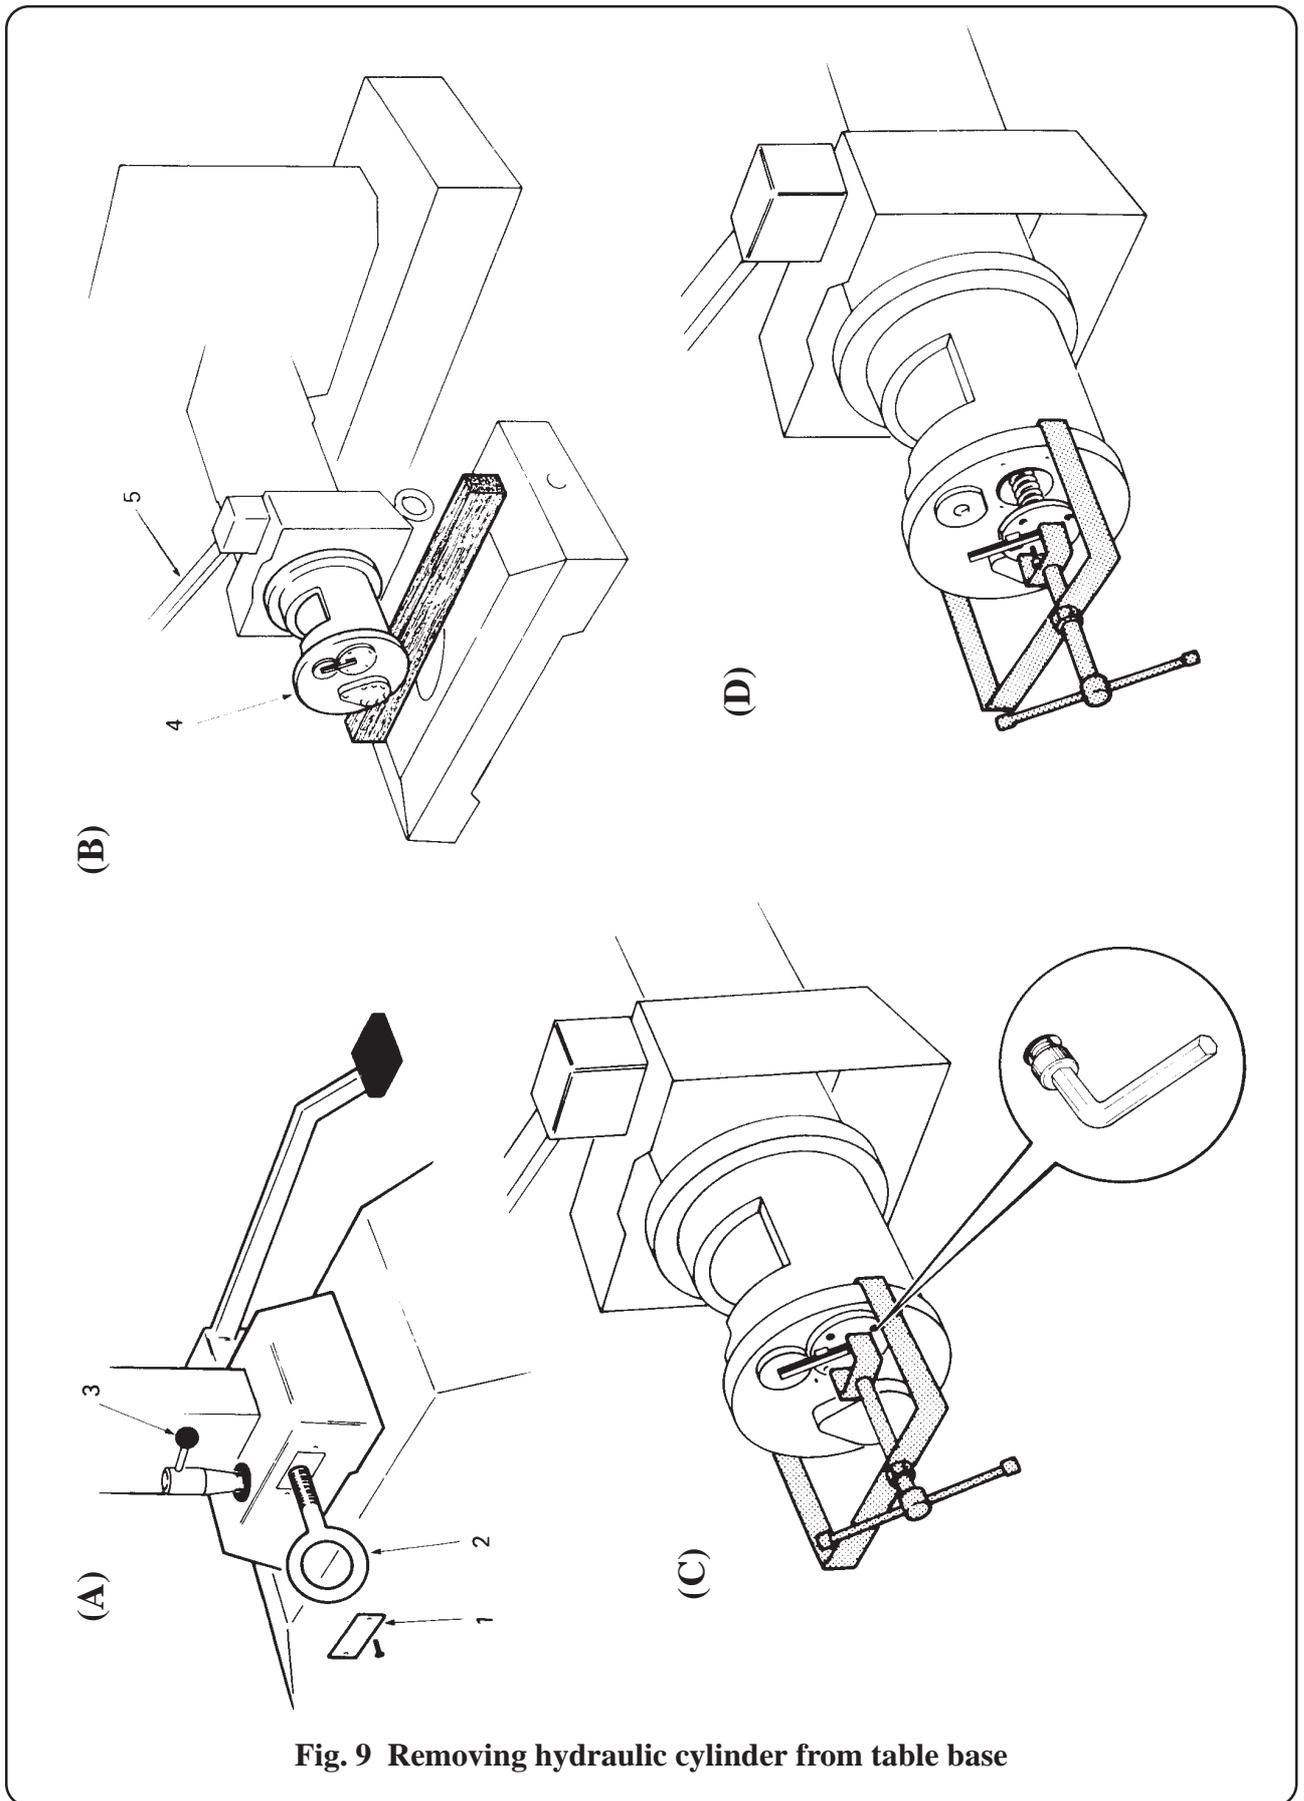
Fig. 9 Removing hydraulic cylinder from table base

this fails, remove hydraulic cylinder from base (see section 4.31); the ball valve should then be disassembled and cleaned (see section 4.33). If the pedal is suddenly inoperable either when raising or lowering the table, refer to section 4.26.

- i Position the compression tool clamp (included in the tool kit available for the MR series tables) across the base of the cylinder (see Fig. 9(c)) and lightly tighten it onto the ram release. Use an Allen key to remove the four screws holding the ram release in position.
- ii Loosen the clamp until oil starts to run from the hole. Allow the oil to drain.
- iii Continue to unscrew the clamp until completely loose then remove clamp and ram release (see Fig. 9(d)).
- iv Refer again to Fig. 11. Adjustment consists of unscrewing, in a clockwise direction, the two large lock nuts (4) on the end of the release plunger (5) to allow more movement of the ram release lever. This is in order to cause the ball of the ball valve to be lifted further and so release the table ram. (For a more detailed explanation of the hydraulic system, refer to section 4.53 and 4.54).

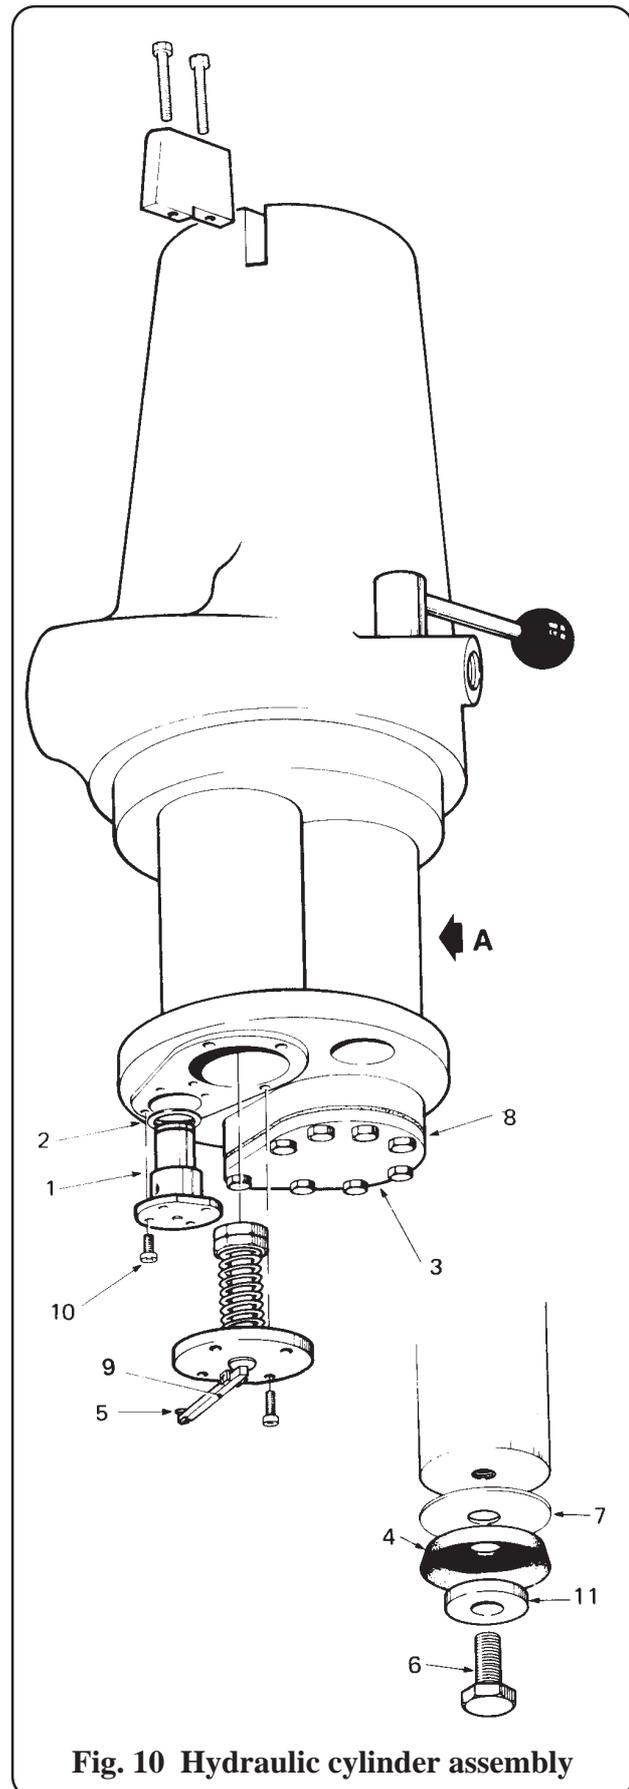
Fig. 10 Hydraulic cylinder assembly

- Condition of ball valve jointing washer (2) Fig. 10. If faulty, replace it (see section 4.33).
- Secureness of ram cover plate (3) Fig. 10. If it is loose, re-tighten it.
- Efficiency of ball valve (1) Fig. 10. If blocked or jammed, disassemble and clean it, (see section 4.31). If the seating of the larger (spring-loaded) ball has been damaged, replace the complete valve.
- Condition of ram cup washer (4) Fig. 10. If worn or chipped, replace it (see section 4.32).

- i Remove cover plate (3) taking care not to damage the sealing gasket; the ram cup washer will then be exposed.
- ii Remove washer retaining screw (6), washer (11), ram cup washer (4) and backing disc (7).
- iii Refit the backing disc (7) together with a new cup washer (4) smearing the latter with a little of the oil used for the table hydraulics.
- iv Refit the retaining screw and its washer but use only *moderate* tension to tighten the retaining screw; too much and the ram cup washer will tend to buckle and allow peripheral oil seepage - too little and oil will leak past the backing disc.
- v Refit cover plate (3) and sealing gasket (8), then manhandle table into base ensuring, before doing so, that the cylinder locking lever (3) Fig. 9 is refitted.

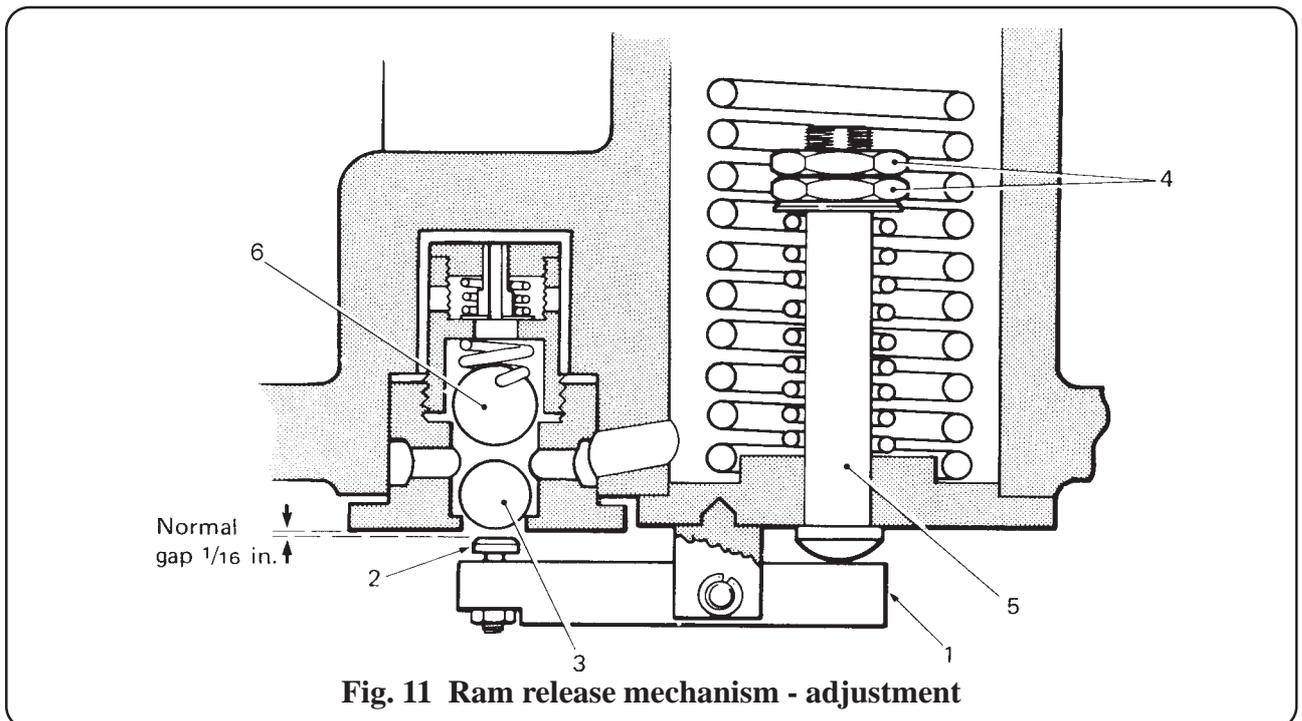
Fig. 11 Ram release mechanism - adjustment

- i Refer to section 4.31 and remove hydraulic cylinder from table base.
- ii Examination of the ram release movement must now be carried out. Refer to Fig. 11. When the pump lever is depressed fully, this operates the ram release lever (1). The ram release lever pivots and the release screw (2) enters the ball valve and should lift the lower ball (3) at the end of lever travel. Before testing this movement, the pressure in the ball valve should be overcome by forcing the release lever into the ball valve after covering the cylinder with a cloth to avoid leakage of oil under pressure.
- iii Now depress the pump lever fully and hold in this position. Test the ram release lever by

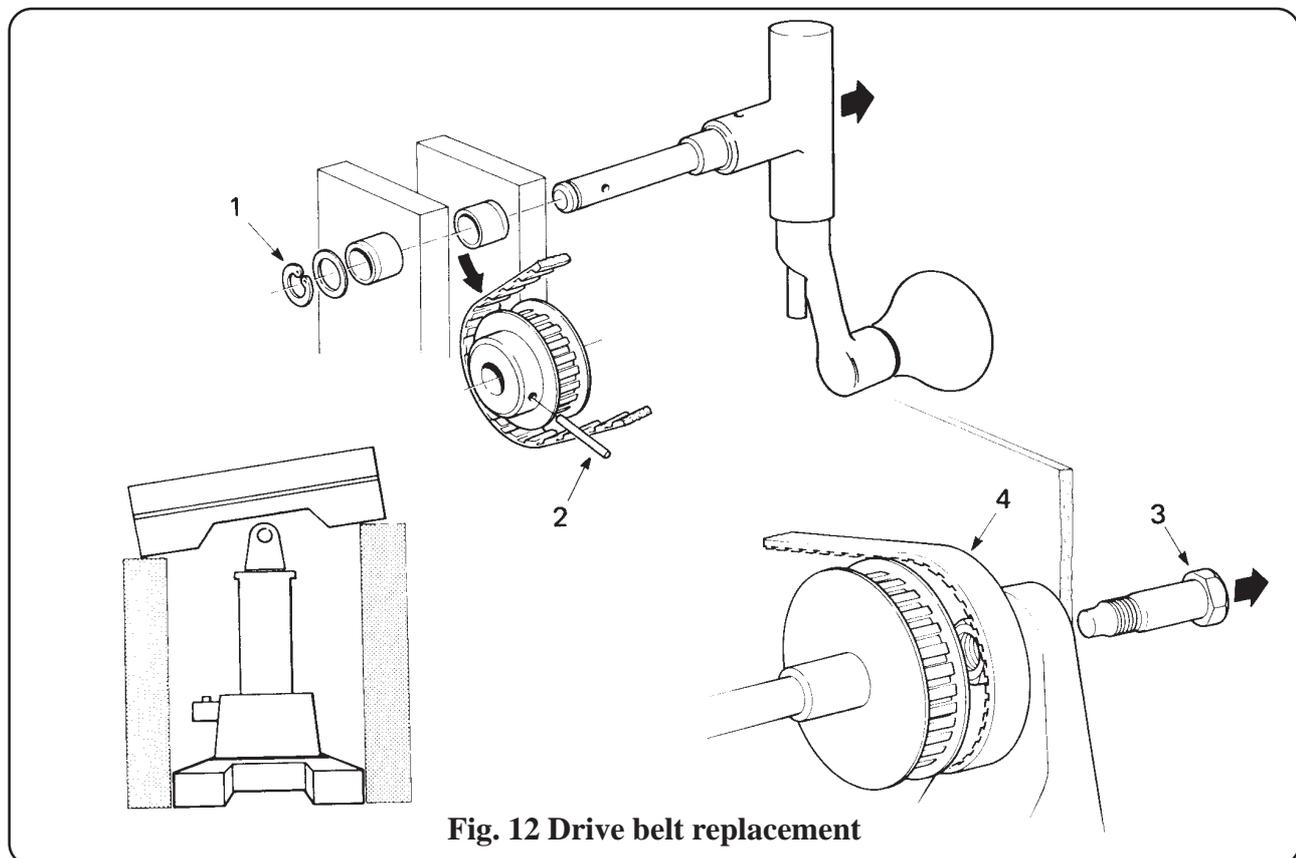
Fig. 12 Drive belt replacement

4.30 If, on examination of the lateral tilt gear drive belt, it appears that the belt needs replacing, proceed as follows:

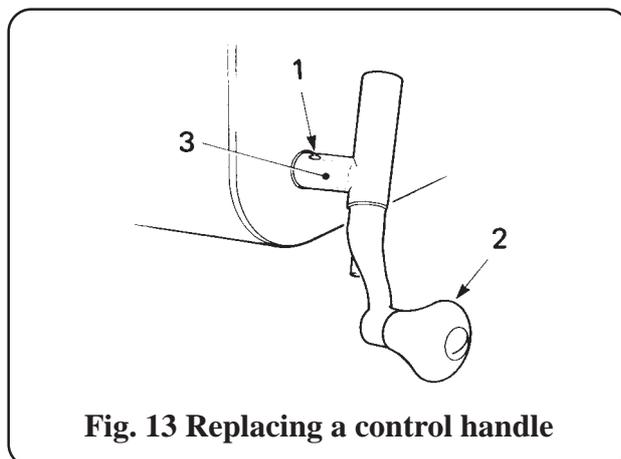
Fig. 13 Replacing a control handle

- ii Take measurement for drilling new handle, then drill (*one* side only) a suitable diameter hole to allow use of a tapered reamer.
- iii Slide new handle onto shaft (3) and align hole through shaft with newly drilled hole in handle.

- iv Complete drilling through handle, using a wooden block for the drill to break into - hence protecting the plating on the handle.
- v Use a tapered reamer to shape out the holes for the taper pin. Fit new taper pin (1) ensuring that it is inserted through the aligned holes the correct way round.

- i Punch out taper pin (1) and remove damaged handle (2).

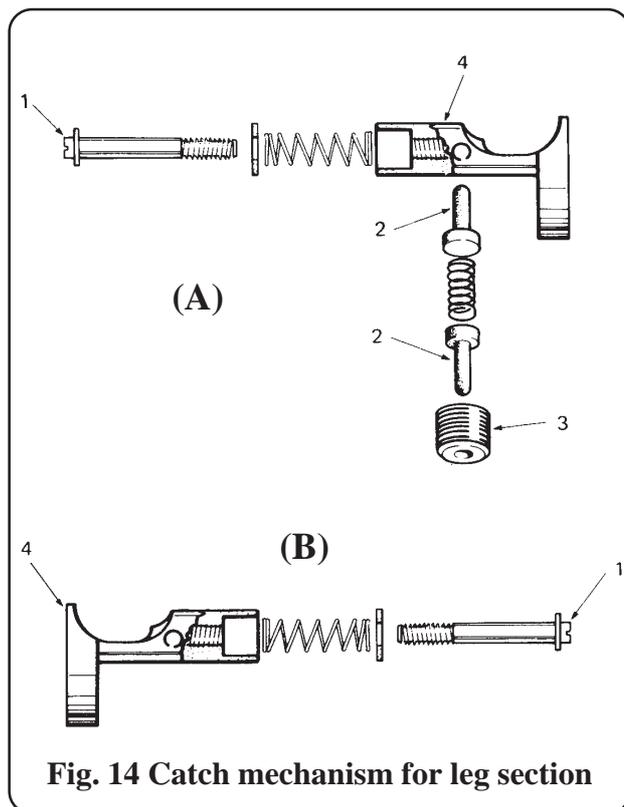
Fig. 14 Catch mechanism for leg section

4.43 Should it be necessary to gain access to the push-button catches for cleaning, lubrication or replacement, first remove the leg section and apply a screwdriver to the slotted end of the threaded spindle of the catch (1). The catch spindles are readily visible at the end of the table trunk section underneath the radiographic top.

4.46 Ensure that the spring loaded plunger (2) referred to in section 4.44 moves freely in its socket. If the plunger has become damaged or distorted such as to impair free movement, it should be replaced. To remove plunger, unscrew threaded bush (3).

4.47 To remove a faulty latch, unscrew threaded spindle (1) completely and lift away push button/latch assembly (4). If the latch has scored the attachment pins of head/leg section the complete push-button/latch should be replaced. Repair any scoring on attachment pins with a fine file and/or crocus cloth before placing in service again.

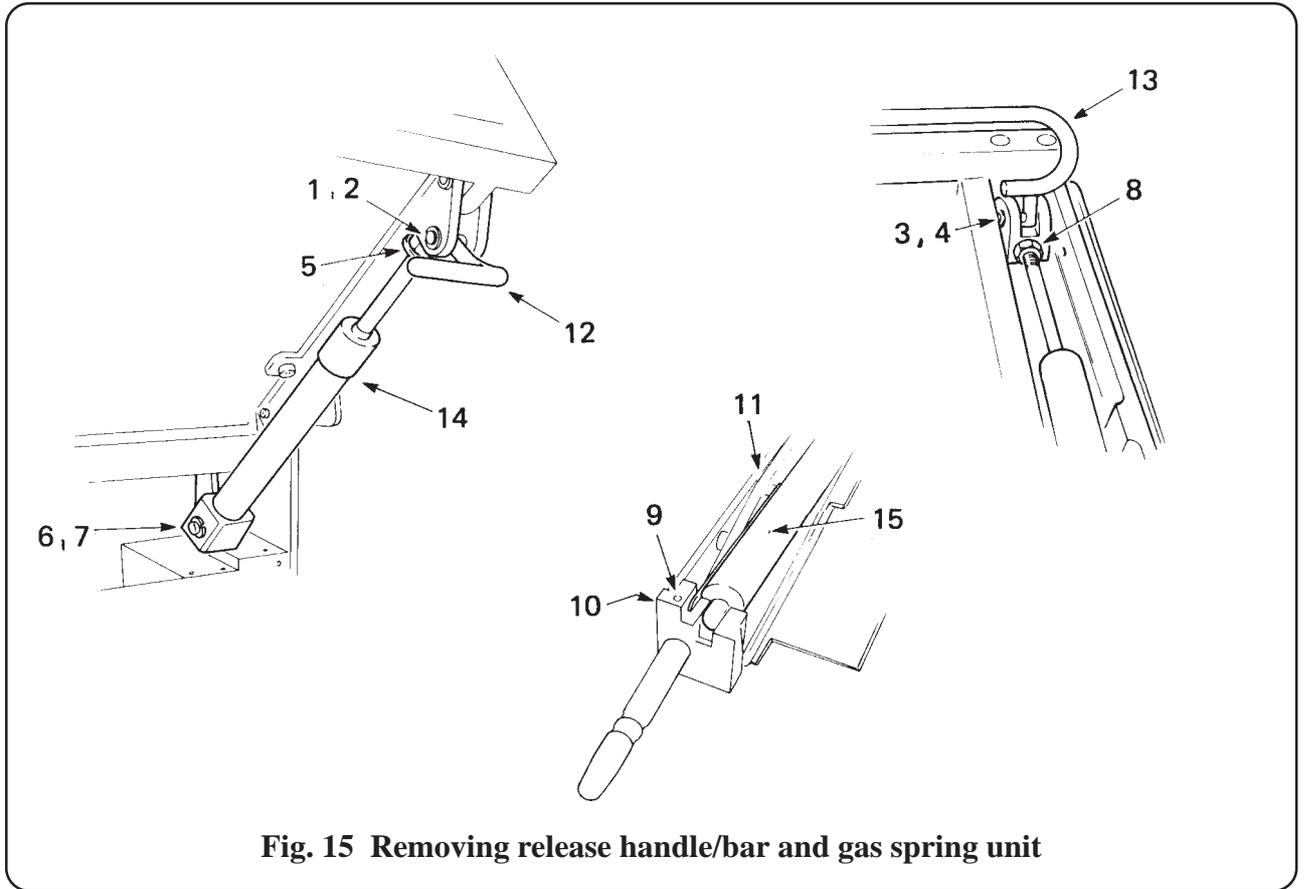
Fig. 15 Removing release handle/bar and gas spring unit

4.48 To detach head section release handle for replacement, extract the release handle pivot pin circlips (1) and tap out the pivot pin (2). Remove release handle (12).

4.49 To detach leg section release bar for replacement, extract the release bar pivot pin circlips (3), on both sides of the leg section, and tap out the pivot pins (4). Remove release bar (13).

4.50 To detach head section gas spring unit for replacement, unscrew hex. nut (5) from release handle trunnion block at piston end then remove pivot pin circlips (6) from bracket supporting cylinder end of unit and tap out the pivot pin (7). Remove gas spring unit (14).

4.51 See warning in section 4.48. To detach a leg section gas spring unit for replacement, unscrew hex. nut (8) from release bar trunnion block at piston end then slacken set screw (9), tap out pivot pin (10) and free stop strap (11) from bracket supporting cylinder end of unit. Remove gas spring unit (15).

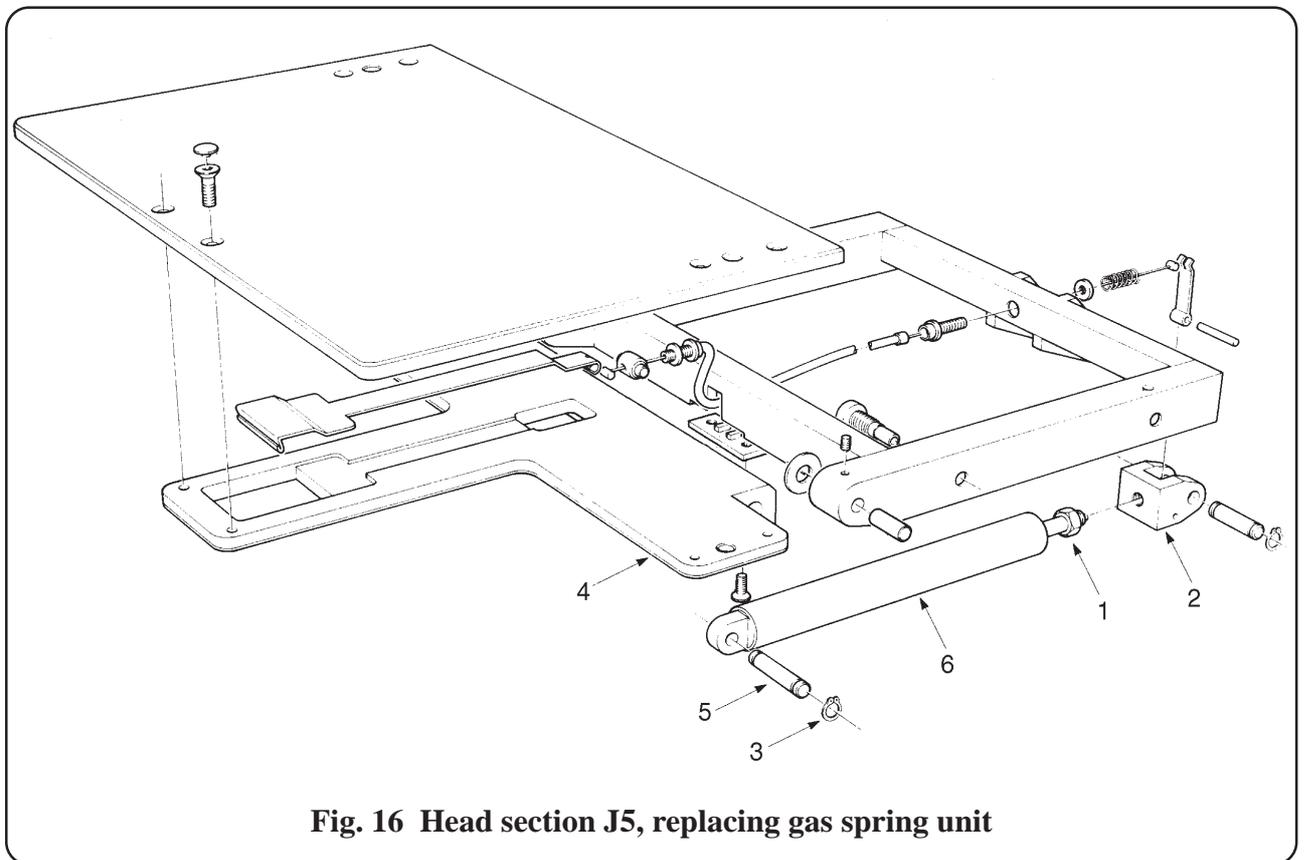
Fig. 16 Head section J5, replacing gas spring unit

4.52 See warning in section 4.48. To detach head section gas spring unit for replacement, unscrew hex. nut (1) from gas spring pivot (2) at piston end then remove pivot pin circlips (3) from hinge plate (4) supporting cylinder end of unit and tap out the pivot pin (5). Remove gas spring unit (6).

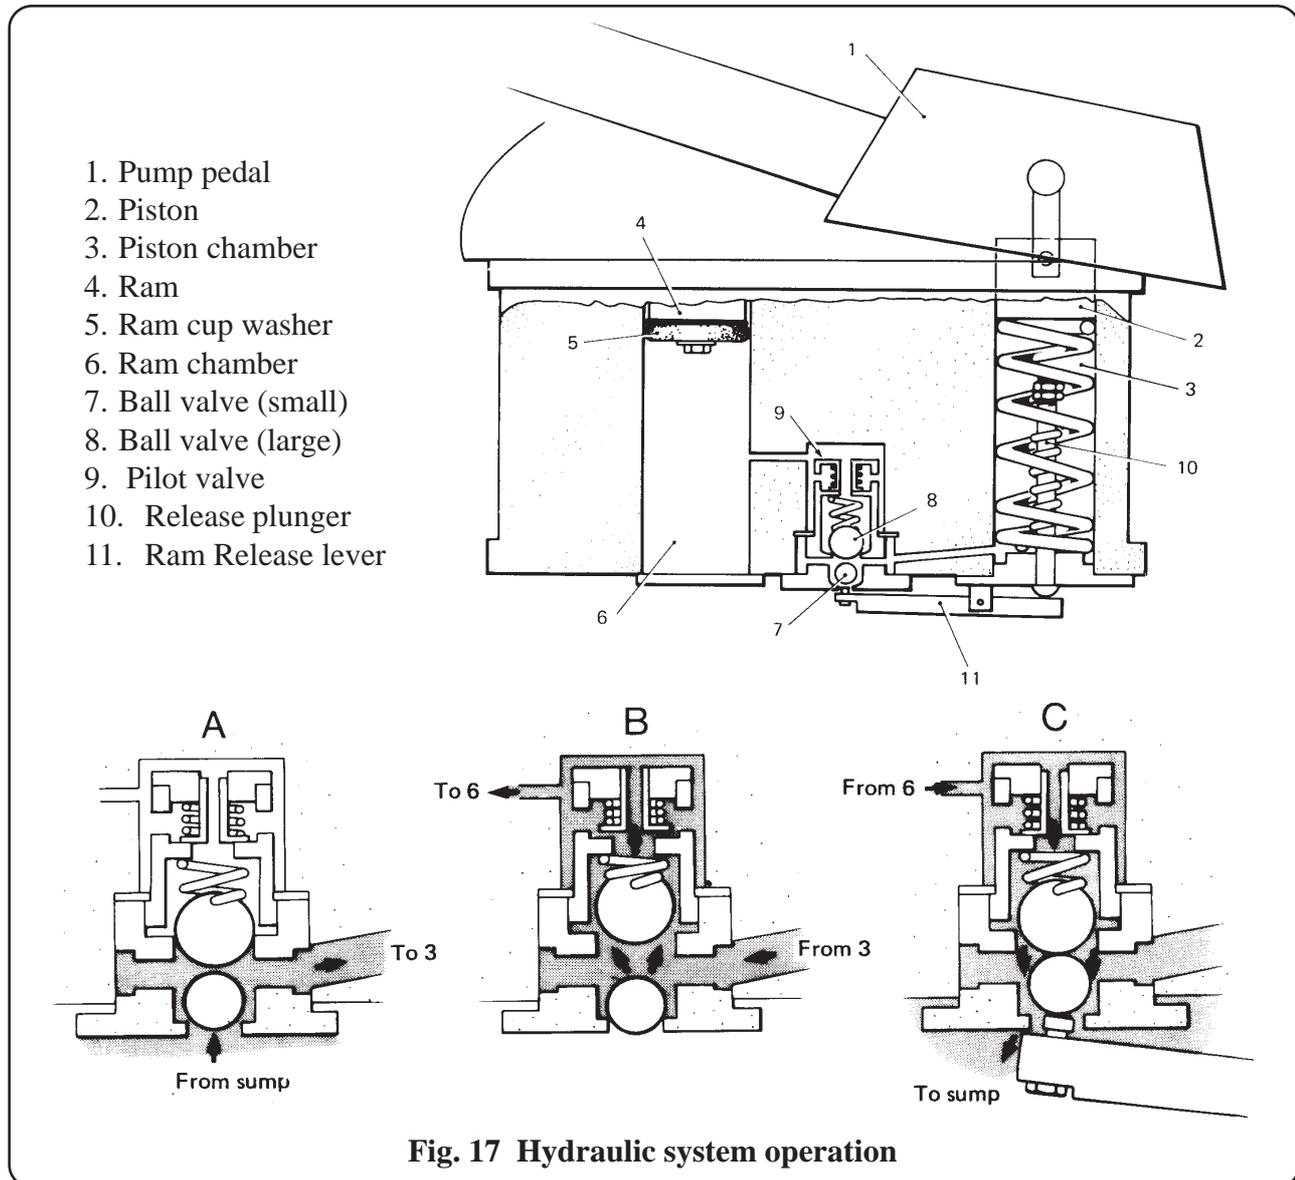
B. Pump pedal down-stroke (using normal foot pressure). Oil under pressure from piston chamber (3) closes small ball-valve (7) but opens large ball-valve (8) and pilot valve (9), allowing pressurised oil to reach the ram chamber (6).

C. Pump pedal pushed fully down. Piston (2) contacts release plunger (10) to operate ram release lever (11) which opens both small and large ball-valves (7) and (8). Oil from ram chamber (6) then flows at a controlled rate back to the sump via *inner bore* of pilot valve while the pilot valve is seated.
